DoE Webinar 14 Sep 2011

Marine Current Turbine's SeaGen technology

David Ainsworth Head of Projects Marine Current Turbines Ltd

SeaGen tidal turbine – environmental mitigation and monitoring

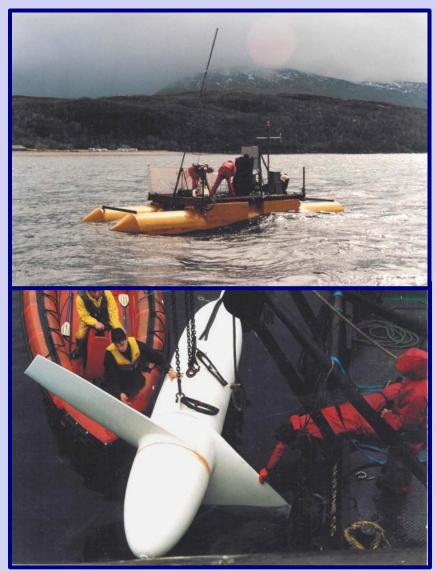
15kW Tidal Current Turbine (1994-5)

PROOF OF CONCEPT PROJECT (IT Power. Scottish Nuclear & NEL) Loch Linnhe, Scotland World's first tidal current turbine

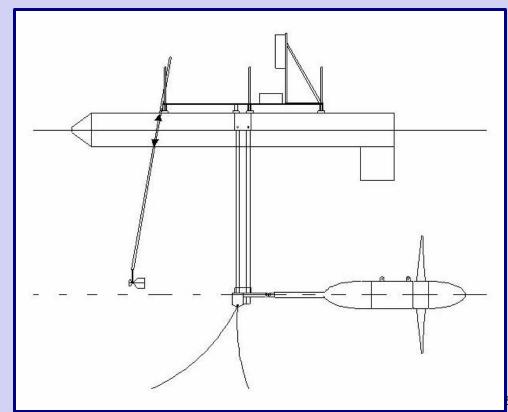
Seaflow installed 30 May 2003 rotor dia. 11m (= 95 sq.m.) rated power 300kW @ 2.5m/s

World's first full-size, and only offshore tidal current turbine

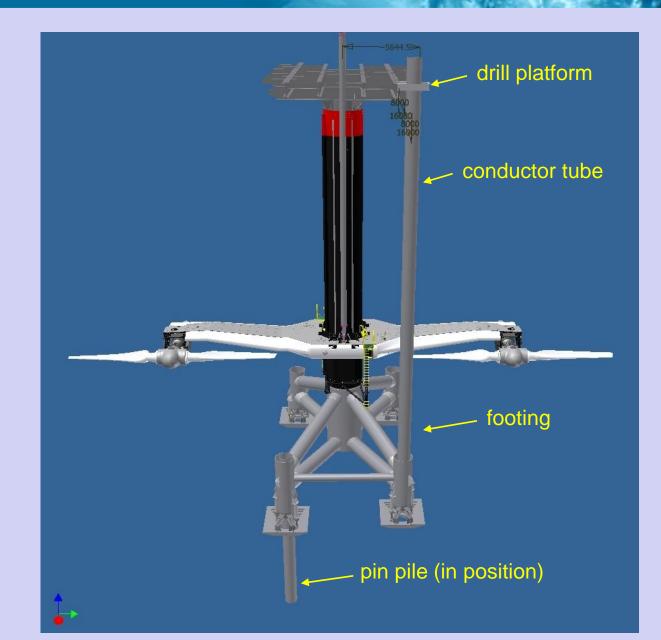
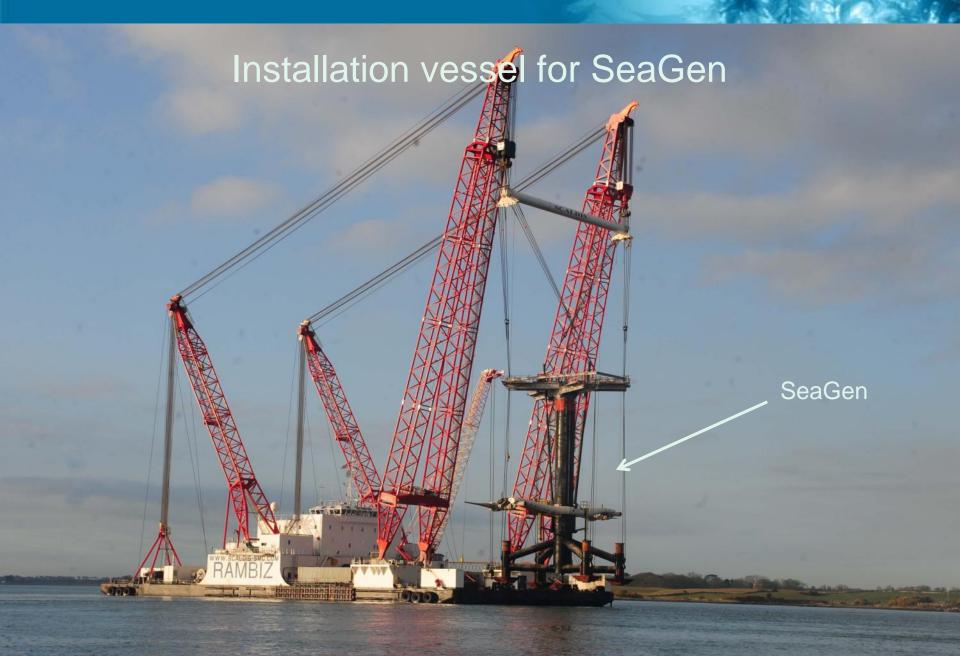
SeaGen Quadrapod

pin-pile installation method

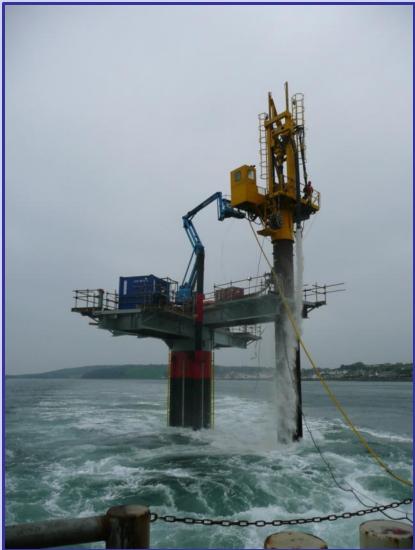
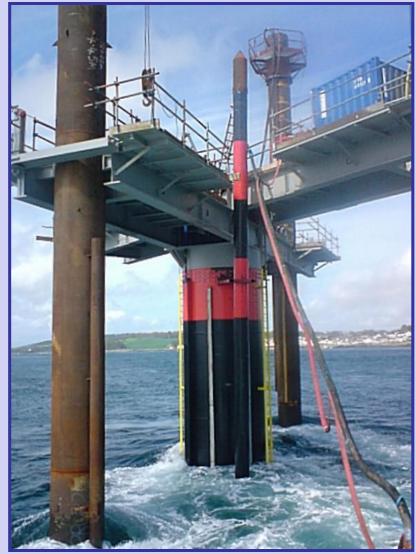
Drilling and Grouting Operations - carried out from temporary work platform

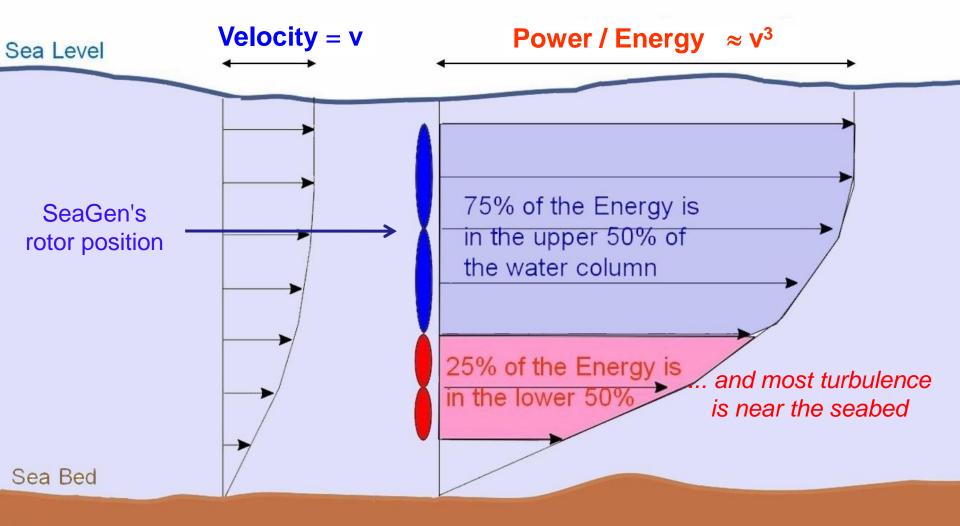
SeaGen maintenance

most maintenance and repair functions can be completed rapidly, using no more than small service vessels: here shown fitting a new rotor blade

Position or rotors in water column: most of the energy in a current is near the surface

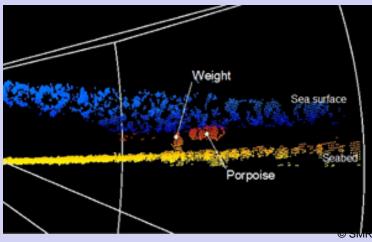
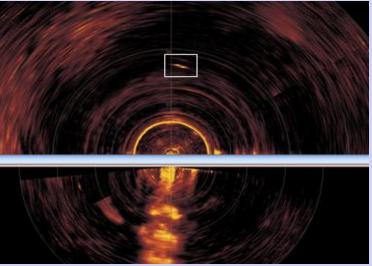
Mitigation - Active sonar (SMRU)

Trail of real time sub-surface sonar imagery of seals, cetaceans and basking sharks close to the SeaGen.

Detection from 80m, well within initial revised shut down action distance of 50m, now reduced to 30m.
