Effect from the construction of Nysted Offshore Wind Farm on seals in Rødsand seal sanctuary based on remote video monitoring

Technical report to Energi E2 A/S

National Environmental Research Institute (NERI)

June 2004

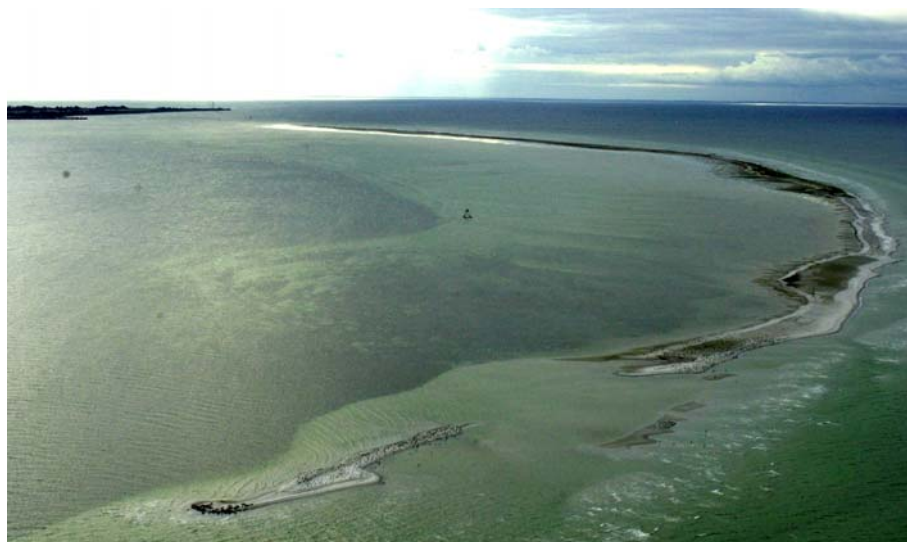
The sandbank is flooded in extreme weather and appears to be in a state of constant alteration as a result of currents and sand deposits.

Figure 2. *The sand bank at Rødsand with the seal sanctuary and seals on land in the lower left corner. The bird tower is seen in the middle of the picture.*

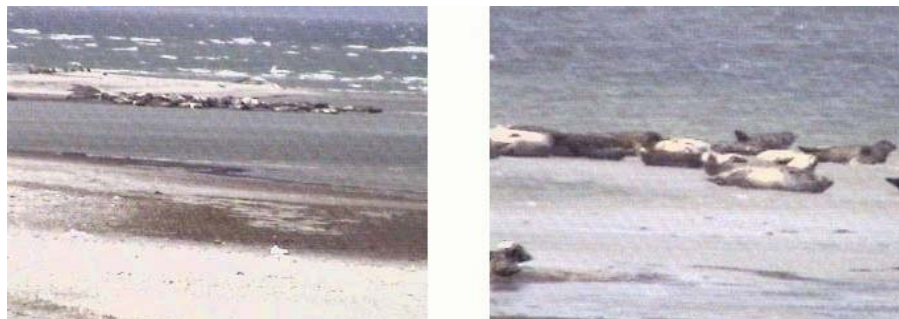
Figure 7. - Stored images showing the seals haul-out site on the tip of Røds- and seal sanctuary on June 6, 2003 at 14:02. (a) The distance and angle from the camera made it difficult to count seals when lying behind each other. (b) On-line counts with a close zoom on the seals revealed 51 seals this particular day.

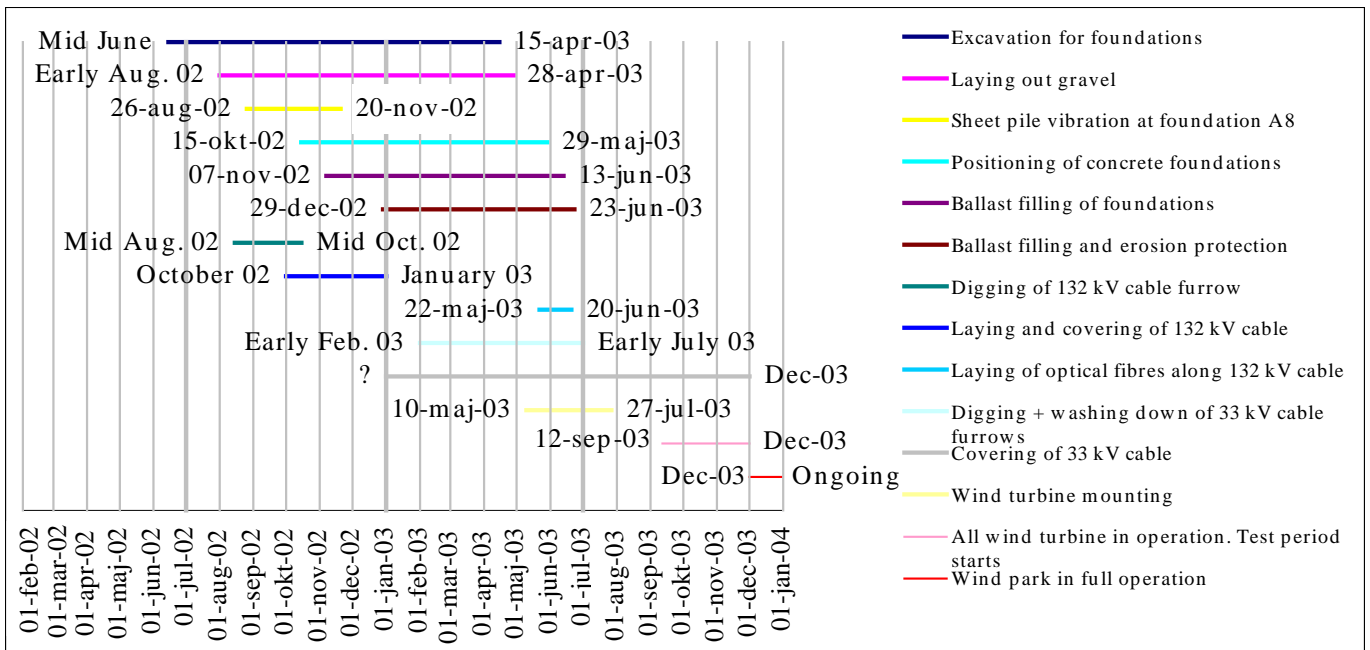
Figure 8. Time schedule of the construction works at the Nysted Offshore Wind Farm

The construction of Nysted Offshore Wind Farm was separated into two major phases. The first phase included preparations for the actual construction work, such as excavation for the foundations, digging of cable furrows and a single case of seabed securing with steel sheet piles. The second phase included cabling and the wind turbine construction. Each of the two faces was divided into several activities scheduled as shown in Figure 8. The construction work began in early February 2002 with the digging of the cable furrows for the 33 kV cables to connect the wind turbines. The last wind turbine was mounted July 27th 2003, and the park was in full operation 1 December 2003.

The construction works at the Nysted Offshore Wind Farm actually started before the cameras became operational, however, the activities during the first 6 months were less intensive and less noisy and primarily took place in the south-west corner of the wind farm furthest away from the seals. Thus, we believe that the disturbance of the seals was minor until the digging of the 132 kV cable from the park to Nysted (parsing close by the seal sanctuary) and the sheet pile vibration started in mid August 2002. In order to assess the potential impact of the construction works, we decided that images recorded before 16 August 2002 were considered baseline data.

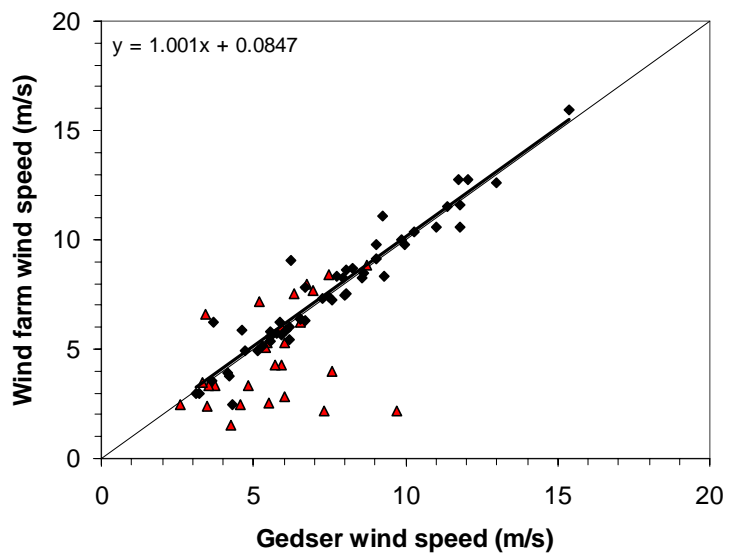
Figure 9. Daily wind speed compared at the two stations (Nysted Offshore Wind Farm and Gedser). Observations marked by red triangles were from the first period of monitoring at the wind farm and were excluded from the dataset. Regression line for wind speed is shown with a bold line.

Daily values of wind speed and direction showed large deviations between the two stations for the first part of the time series monitored at the Nysted Offshore Wind Farm (Fig. 9 and 10). Discarding the observations from the first short-term periods of monitoring at the wind farm (red triangles in Fig. 9 and 10) revealed a consistent pattern with almost identical signals. The regression line for wind speed was not different from the identity line, whereas there was an almost constant displacement of 21.5° for wind directions (Fig. 10). A combined wind signal of hourly observations was obtained

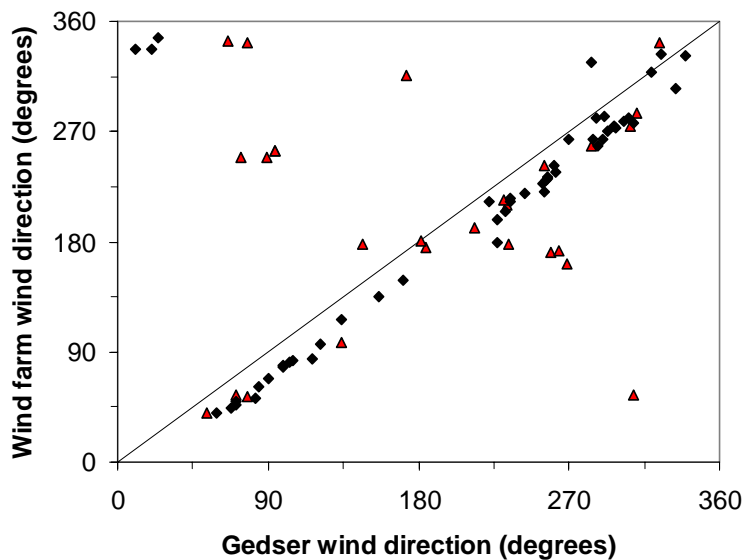
Figure 10. Daily wind direction compared at the two stations (Nysted Offshore Wind Farm and Gedser). Observations marked by red triangles were from the first period of monitoring at the wind farm and were excluded from the dataset.

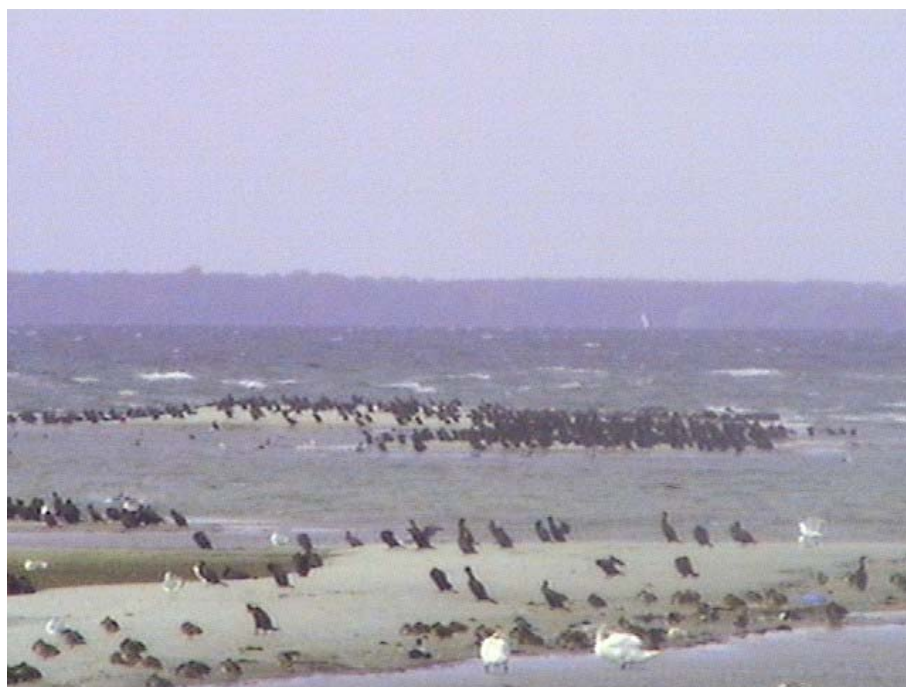
Figure 11. The image shows the seals preferred haul-out site on the tip of Rødsand seal sanctuary on September 17, 2002 at 15:06. The distance and the angle from the camera made it difficult to count the seals lying behind the black cormorant (*Phalacrocorax carbo*).

In order not to disturb the seals the tower was initially placed distant (900 m) from the haul-out site and then later moved closer to the seals. At the first location the tower with the two cameras was deployed on 20 March 2002. The great distance and the small angle from the cameras to the seals made it very difficult to count the seals when more than 20 seals were present or when many birds were on land, as they were shading for each other (Fig. 11). The quality of the photos was too poor to extract behavioural information. Therefore the tower was moved to a site approximately 600 m from the haul-out site on 14 August 2002. Eventually the tower was moved to its final destination approximately 300 m from the haul-out site on 9 April 2003. Deposition of sand in the seal sanctuary changes constantly and the distance to the seals therefore varies over the year.

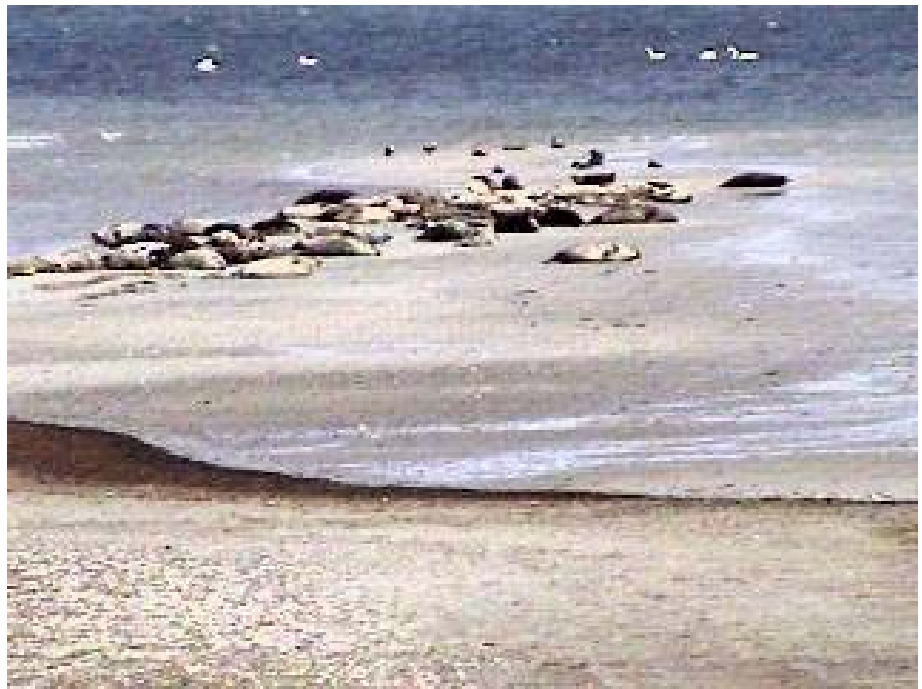
Figure 12. The image shows the seals preferred haul-out site on the tip of Rødsand seal sanctuary on June 13, 2003 at 10:13 after the movement of the camera-tower. The distance to the seals was now 300 m.

After having moved the tower to a distance of 300 m from the seals the angle was steep enough to avoid the shading effect (Fig. 12).

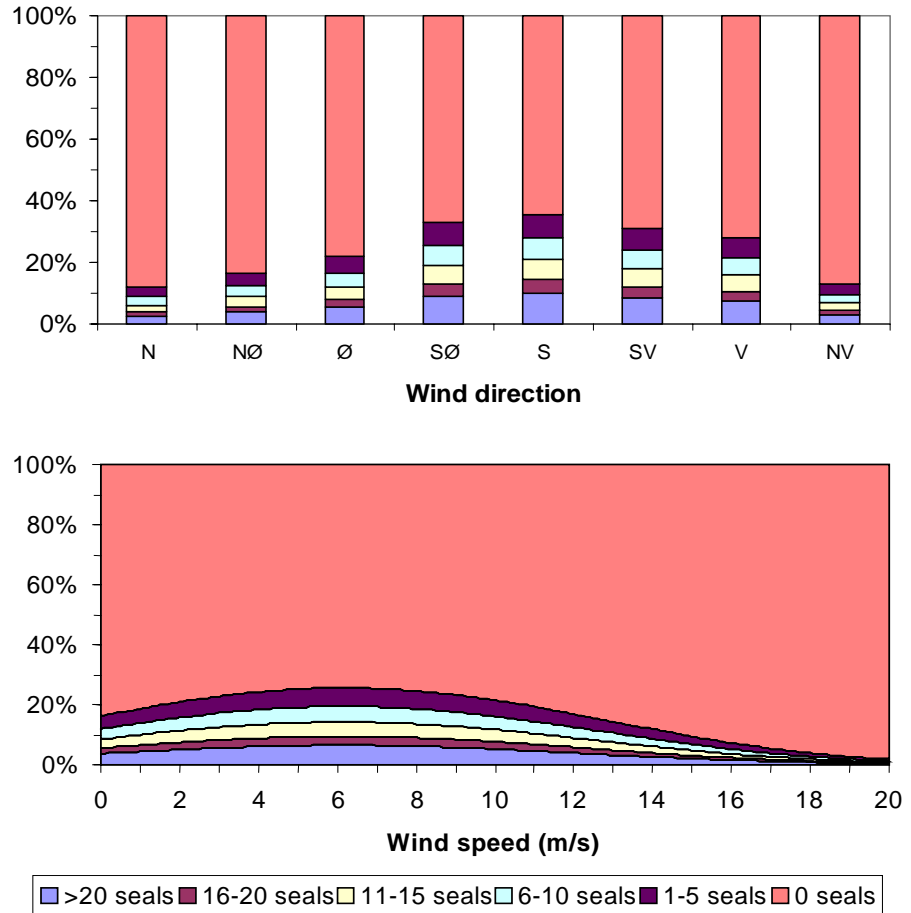
Figure 15. Estimated distributions for the 6 seal categories for different wind direction (top) and wind speed (bottom). The category probabilities were calculated as marginal means from a multinomial model describing yearly conditions for all hours between 4 and 23.

Southerly winds around 4-8 m/s increased the number of seals on land (Fig. 15). If the wind came from the south (S) there would be a yearly mean of 5.0 seals on land, whereas if the wind was from the north (N) there would only be a yearly mean of 1.5 seals on land. The yearly mean number of seals on land increased from 2.0 seals at 0 m/s, reaching a maximum of 3.4 seals at 6.1 m/s and decreased to 0.2 seals at 20 m/s. Wind speed between 0 and 12 m/s generally resulted in high abundance, whereas strong winds did not favour seals on land.

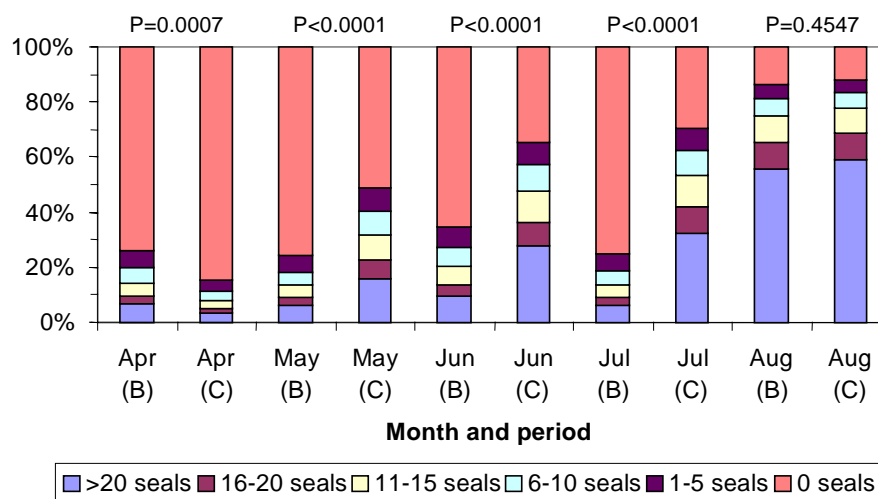
Figure 16. Estimated distributions for the 6 seal categories for months with camera in operation during baseline (B) and the construction period (C). The category probabilities were calculated as marginal means from a multinomial model. P-values above the columns give the probability that the distributions are identical for the two months.

The small increase in the seal category probabilities from baseline to the construction period was not equal for all the months (the interaction effect $period \times month$ was significant). Five months had seals observations in both the baseline and the construction period, and four of these had a significant difference in the category probabilities for the two periods (Fig. 16). There was a decline in the number of seals on land from 3.4 seals in April 2002 to 1.9 seals in April 2003, whereas data from May, June and July all showed increases from 2002 to 2003 (3.2 increasing to 7.3 for May, 4.8 to 11.0 for June, and 3.3 to 12.3 for July). The small increase from 17.6 seals in first half of August 2002 to 18.3 seals on land in second half of August 2002 and August 2003 was not significant.

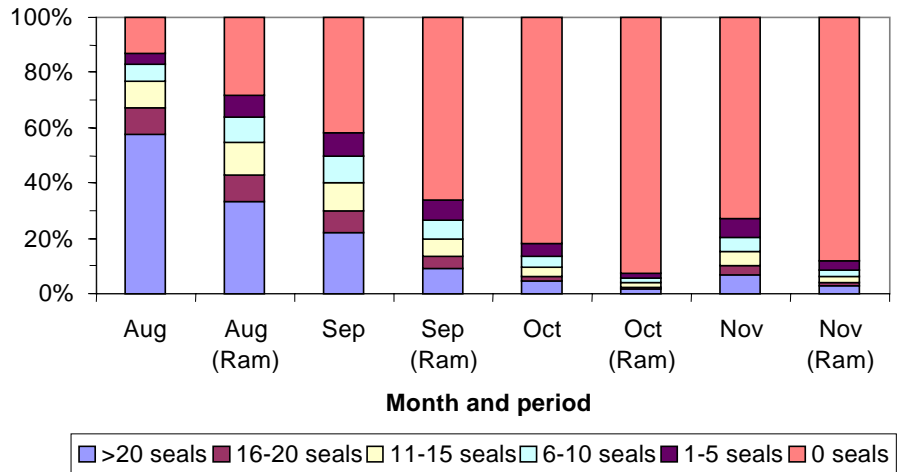
Figure 17. Estimated distributions for the 6 seal categories for periods during the four month with ramming activities (Ram) compared to periods without ramming activities in 2002. The category probabilities were calculated as marginal means from a multinomial model.

Ramming/vibration activities were carried out at a single foundation (A8) located approximately 10 km from the seal sanctuary. Seal category probabilities were significantly different ($P < 0.0001$) during the periods of ramming when all other sources of variation were taken into account. There was a decrease in the number of seals on land during ramming/vibration periods (Fig. 17). It was not possible to test for month-specific effects of ramming periods, since most of the ramming data were from September 2002.

Ramming periods were associated with a decline from 18.0 seals to 12.5 seals in August (30.6% reduction), from 9.3 seals to 4.6 seals in September (50.5% reduction), from 2.3 to 0.9 seals in October (60.9% reduction), and from 3.6 seals to 1.5 seals in November (58.3% reduction). These modelled changes were determined from the observations taking other factors such as wind, month and time of the day into account. However, the actual decreases were less than modelled in August (from 13.6 seals to 12.1 seals; 11.0% reduction) and in September (from 9.5 seals to 8.7; 8.4% reduction), whereas the decrease was substantially larger in November (from 13.2 seals to 0.0 seals; 100% reduction). In fact, for the 25 hourly camera observations during ramming periods in November, no seals were observed on land.
