Decommissioning of the SeaGen tidal turbine in Strangford Lough, Northern Ireland: Environmental Statement

Document Ref: J/2/4/16	Originator: Dr Gareth Johnson
Date: 12/09/2016	Circulation: Consultation

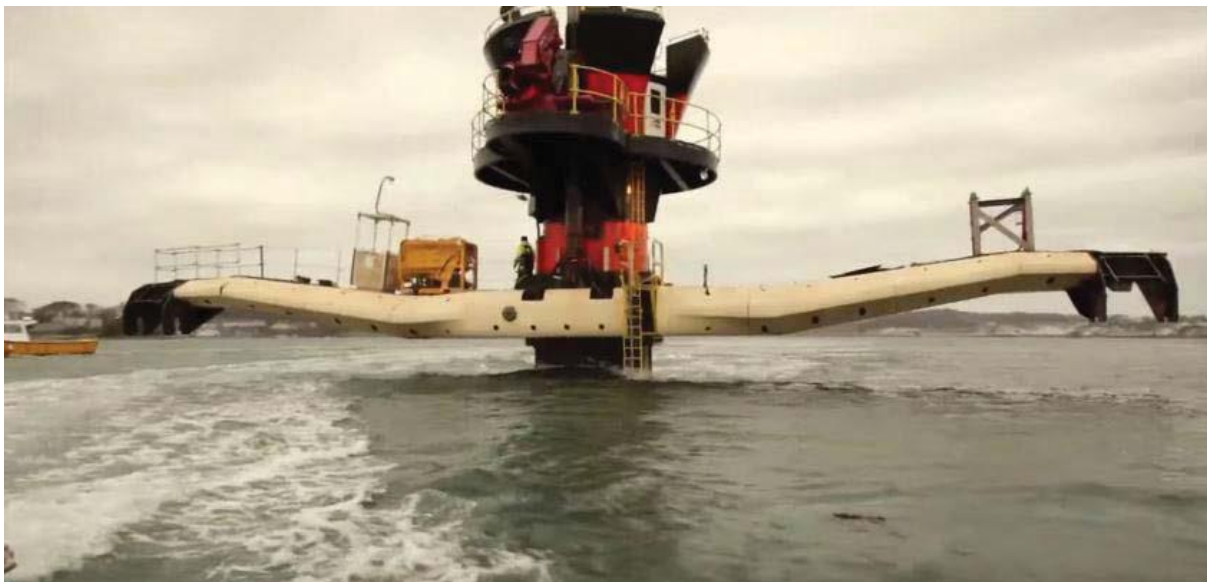
Figure 1.2: SeaGen Device in Strangford Lough with Powertrains Removed (From: SeaGen, 2016)

The SeaGen device consisted of two 16 m diameter rotors and powertrains supported on a crossbeam that is affixed to a central tubular structure with a control unit on top. The rotors and powertrains were removed in May 2016. The device is secured in position using a quadropod foundation fixed on the seabed using drilled pin piles approximately 1 m diameter, 14 m long, and drilled to a depth of approximately 9 m (Figure 1.2). Each of the quadropod legs contains grout and concrete.

Phase 1 - Removal of powertrains and rotors: These works were completed in May 2016, leaving the cross beam and the superstructure and foundations in-situ. The crossbeam was returned to its operational position following powertrain and rotor removal.

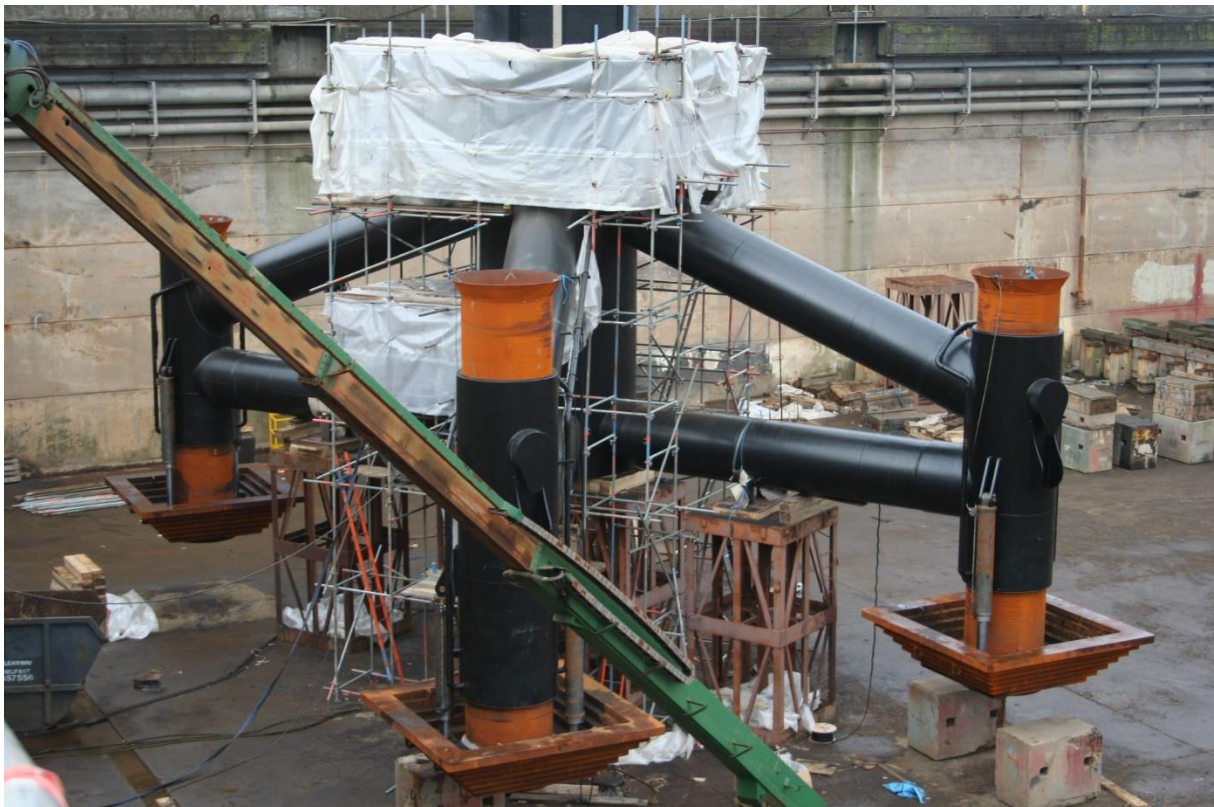
Figure 4.2: Image showing the base of the SeaGen device including the four feet (Image provided by SGL, 2016)

The preferred cutting location would be through the pin piles above the SeaGen feet (Figure 4.1; Figure 4.2) leaving four foot in-situ. This cutting location has been agreed with the Decommissioning Working Group as the most preferable cutting location due to the environmental damage associated with removing the feet to the level of the seabed. However, until the final decommissioning procedure has been confirmed by the preferred contractor consideration will also be given to cutting through the main central pile.

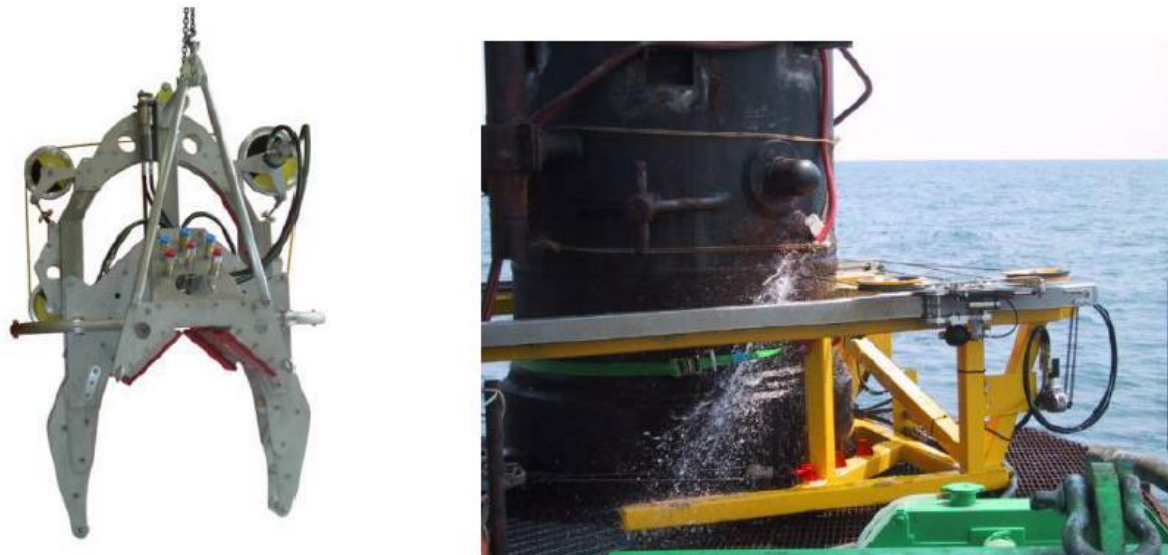
Figure 4.3: Example of a Diamond Wire Cutting Tool (From: MOJO Maritime, 2012)

This is a relatively time and cost-effective means of performing a remotely performed subsea cut. The equipment required is available, industry proven and has a very low environmental impact (Atlantis, 2016) (Figure 4.3).

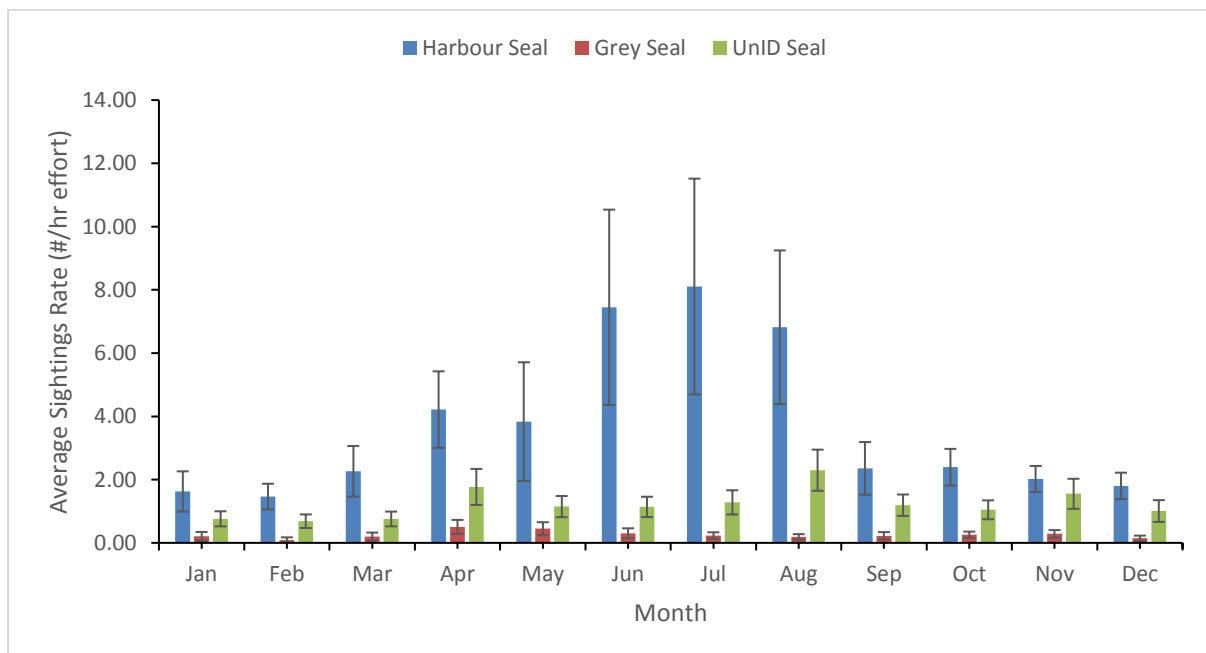
Figure 10.2: Seal monthly sightings rates during the land based vantage point surveys in the Narrows between May 2005 and Oct 2010. Error bars show 95% Confidence intervals.
