Hawaii National Marine Renewable Energy Center (HINMREC)

Kāneʻohe Wave Energy Test Site: Remotely Operated Vehicle Survey

Prepared by:
Sea Engineering, Inc.

February 2012

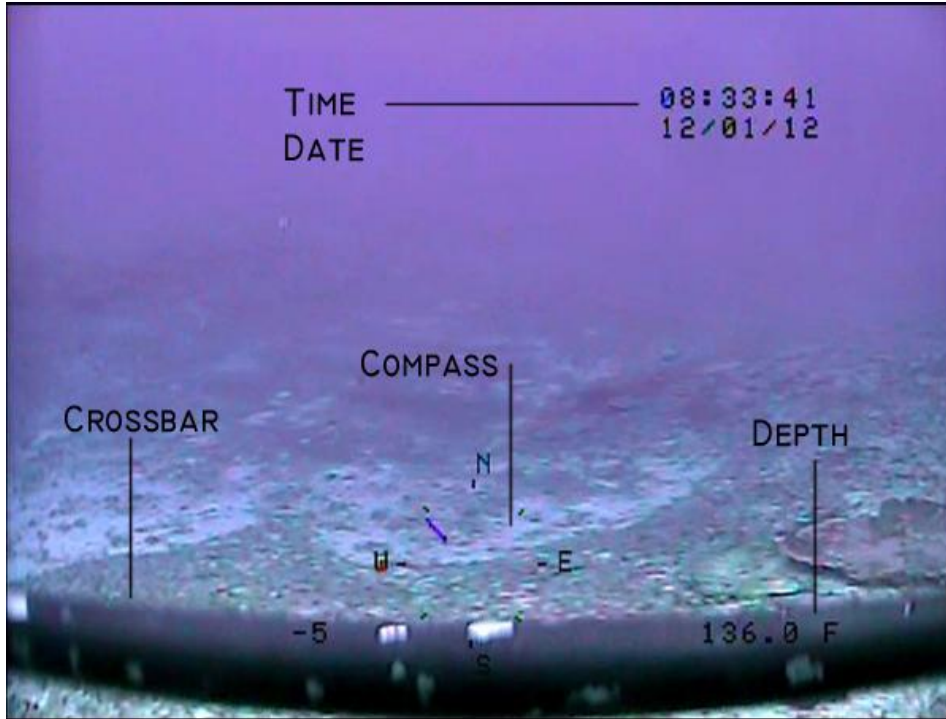
For this survey, an Outland Technology Model 1000 ROV was utilized. This ROV is equipped with two forward facing cameras, a color and a black and white low light, which can rotate 360°; and one rear facing fixed camera. The forward facing color camera was used for the majority of this project with a small portion of the video done with the rear facing camera. All the camera displays are overlaid with a compass, depth indicator (indication in feet), date, and time. Sample images from the ROV are shown in Figure 2-1 and Figure 2-2. The crossbar, visible in the Figure 2-1 is fixed on the ROV and does not rotate with the camera. When the crossbar is visible in the bottom of the screen, the camera is looking straight ahead. The forward facing low light camera is black and white and was not used for this project.

Figure 2-1: Forward facing ROV camera

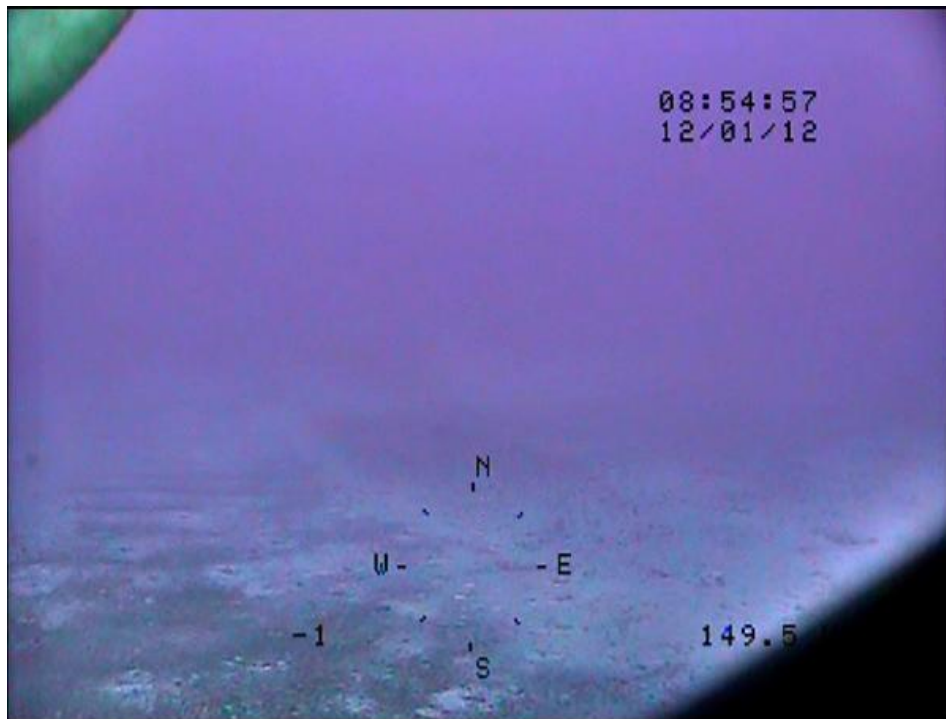
Figure 2-2: Rear facing camera, cable visible in upper left corner, ROV frame in bottom right.

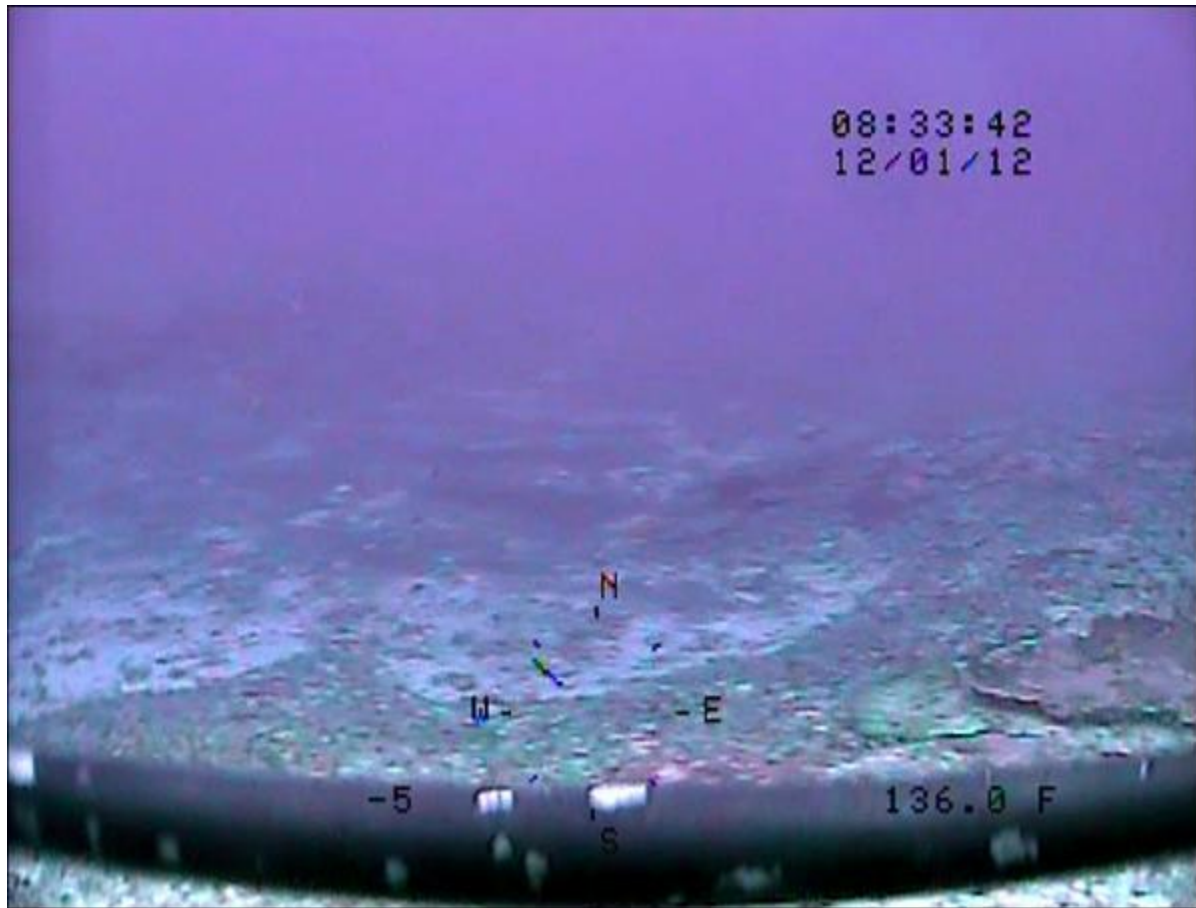
The dive at Site 1 was conducted in the southeastern corner of the test area in water depths of 40-45 meters. Based on the previous surveys, this area was interpreted to be a steeply sloping, irregular, hard reef limestone bottom. The ROV video confirmed this interpretation. A relatively steep slope with undercut reef shelves and ledges was located. Scattered coral cover was noted in the area.

Figure 3-1: Image from Site 1

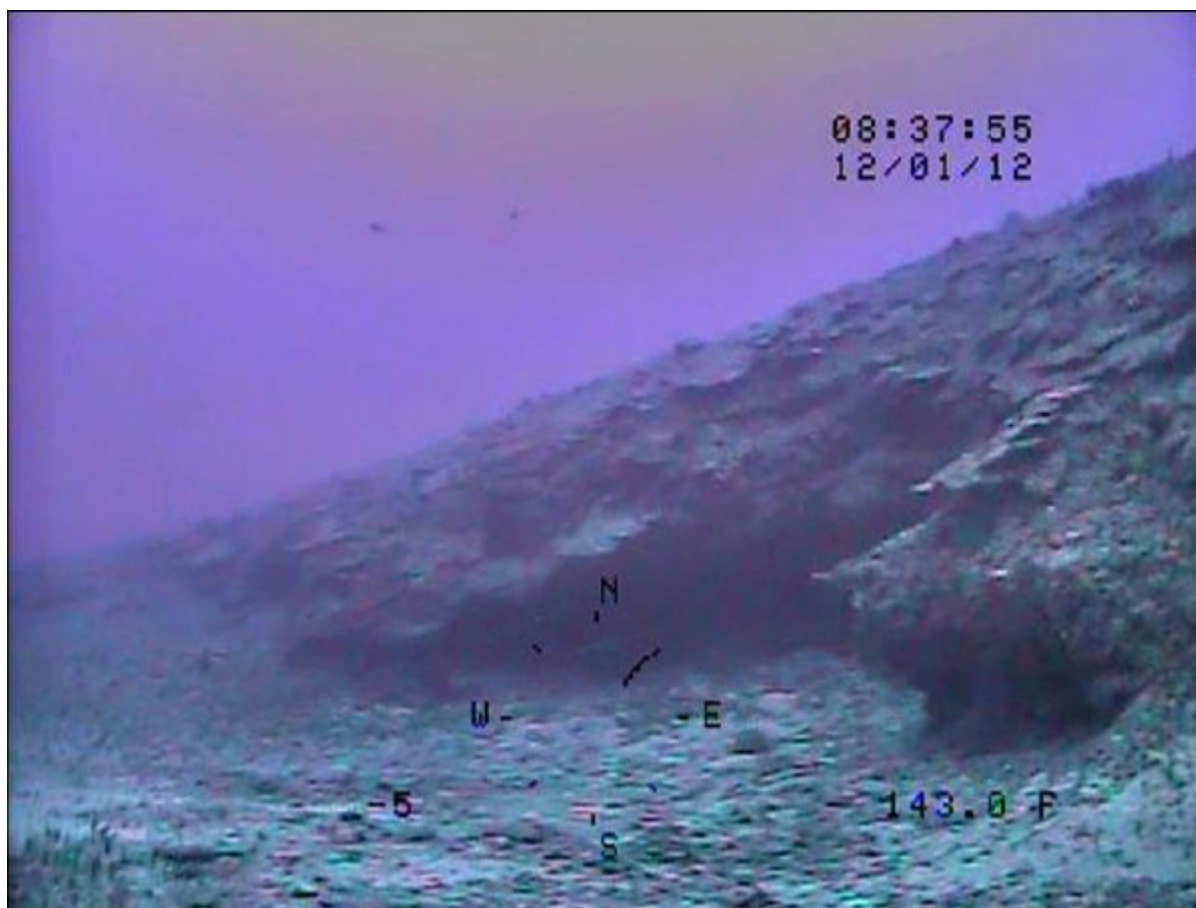
Figure 3-2: Ledge at Site 1

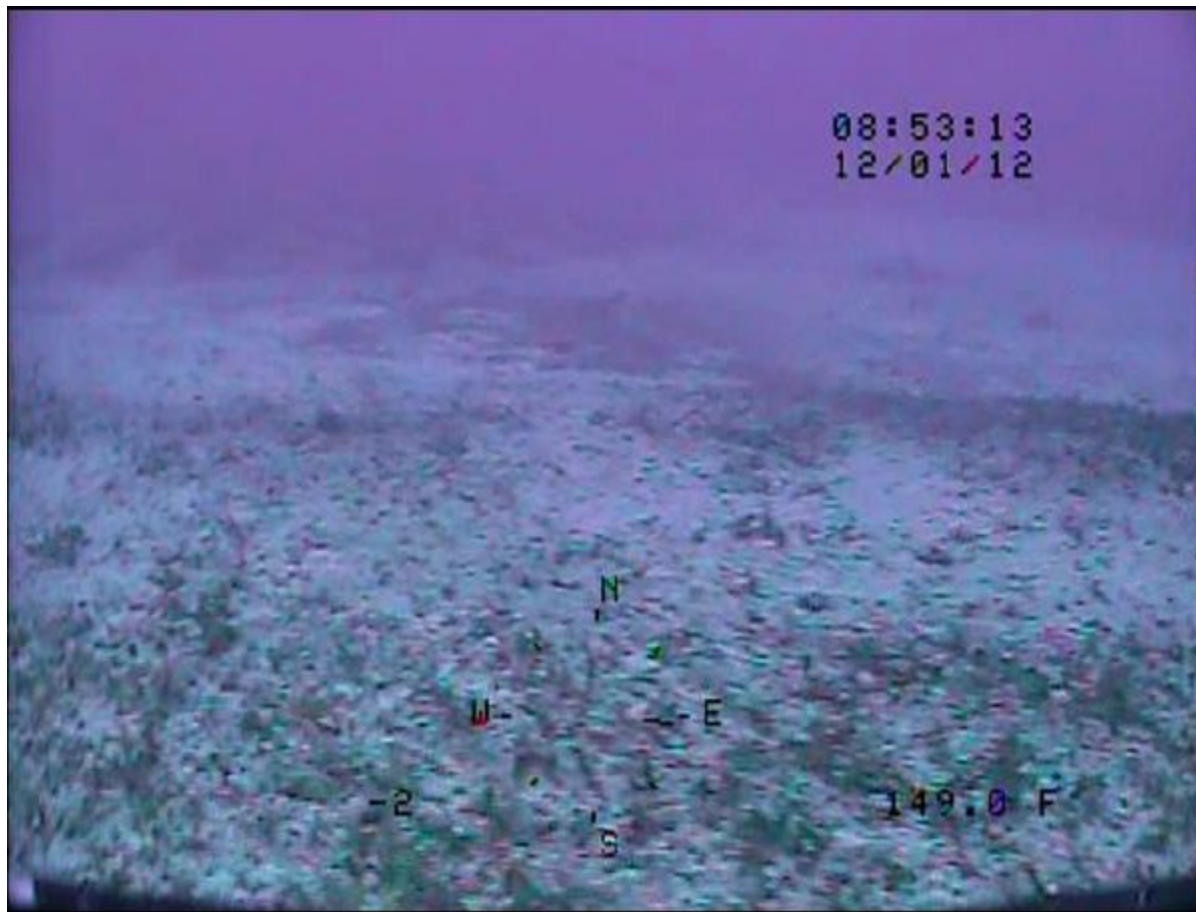
Dive 2 was conducted seaward of the base of the 40-45m limestone escarpment, at a water depth of 48-50 meters in a gently sloping, hard bottom area. The bottom was confirmed to be limestone reef with thin sand cover, algae and isolated patches of coral.

Figure 3-3: Hard bottom with thin layer of sand and algae, Site 2

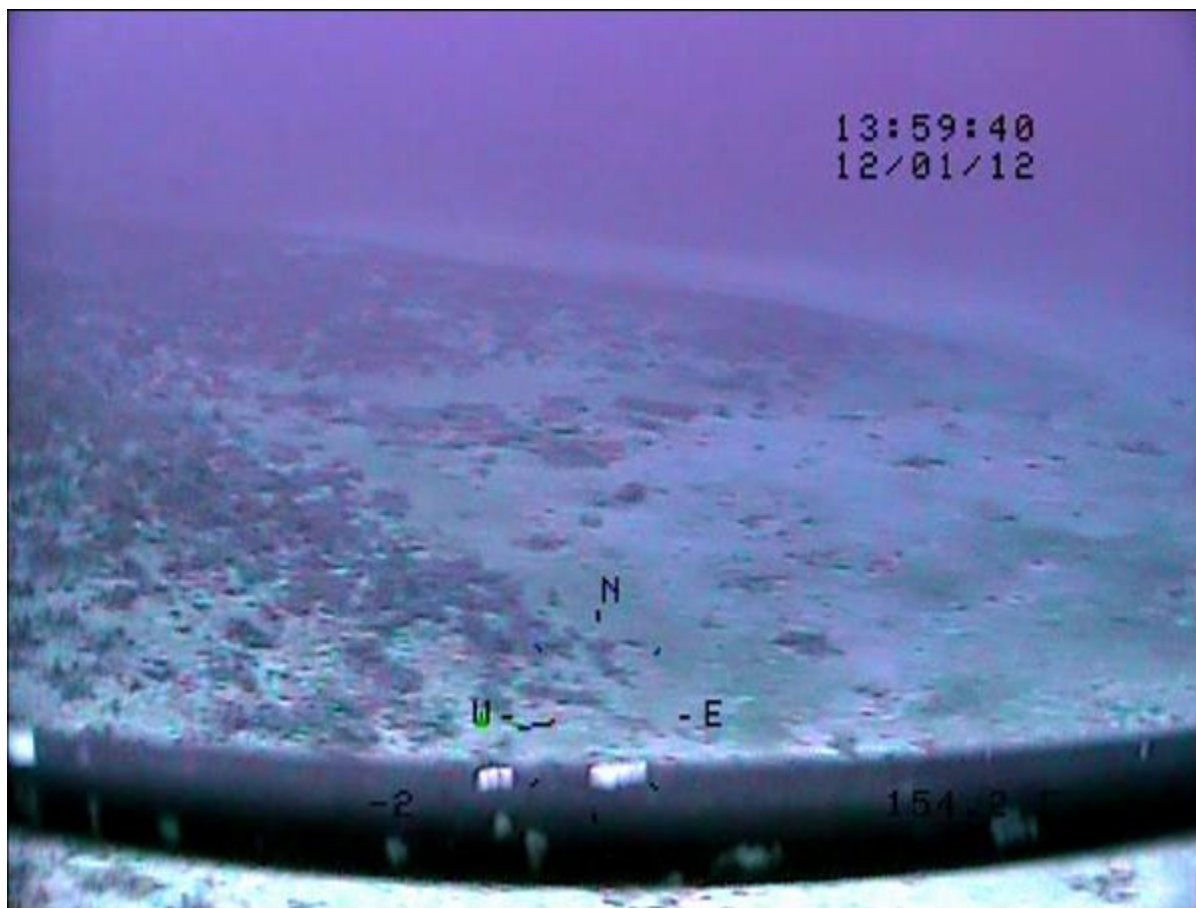
Site 3.1 was located at the west edge of the project area at the transition between the hard limestone bottom and sand. Figure 3-4 shows the hard bottom to the left of the image and sand extending seaward on the right side of the photograph.

Figure 3-4: Transition from reef limestone bottom with algae (left side of photograph) to thick sandy bottom (right) at Site 3.1 (second dive at site 3)

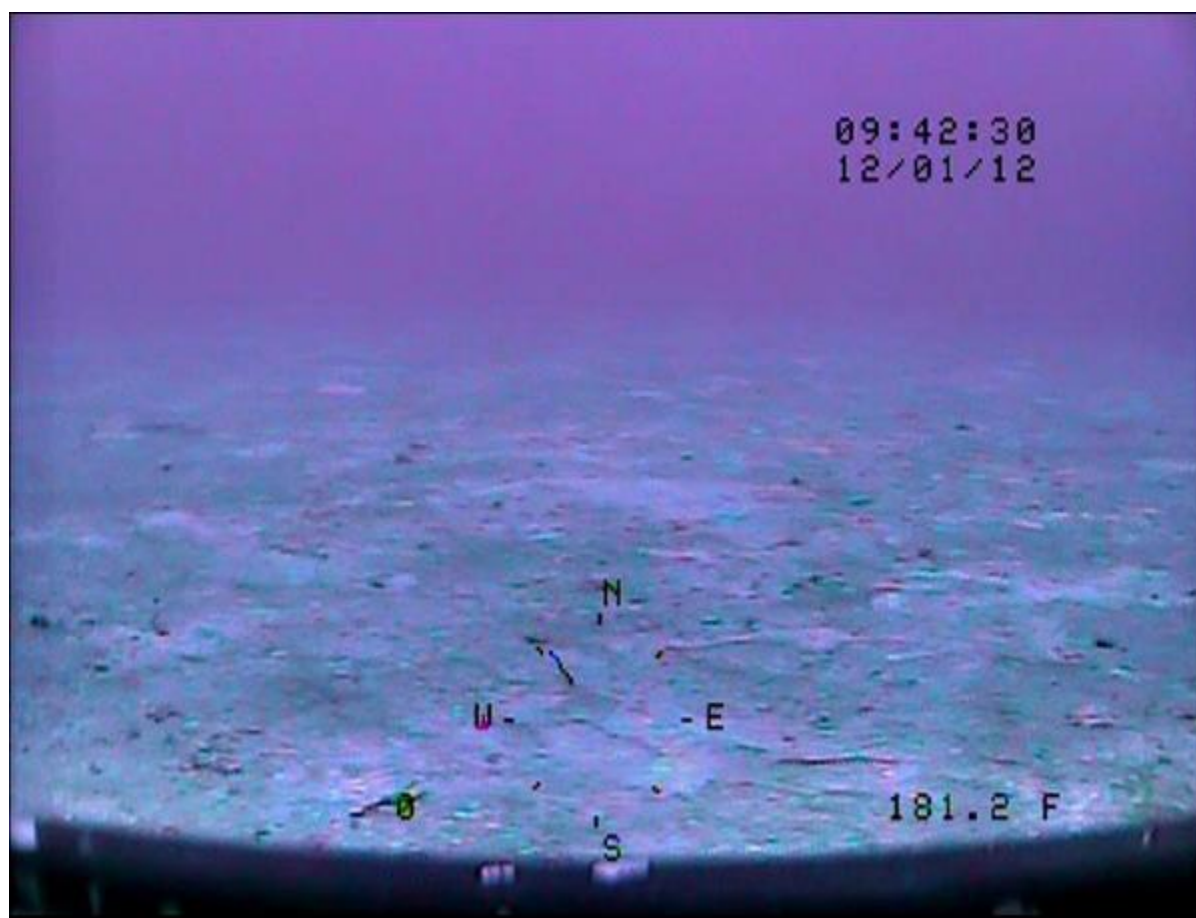
The dives at Sites 3-8 were conducted on the proposed anchor sites in the test area in water depths varying from 51 to 86 meters. The sites were located in areas where sand thickness was estimated to be greater than 5 meters. The ROV survey confirmed that the bottom was sandy with scattered patches of algae.

Figure 3-5: Sand at Site 4

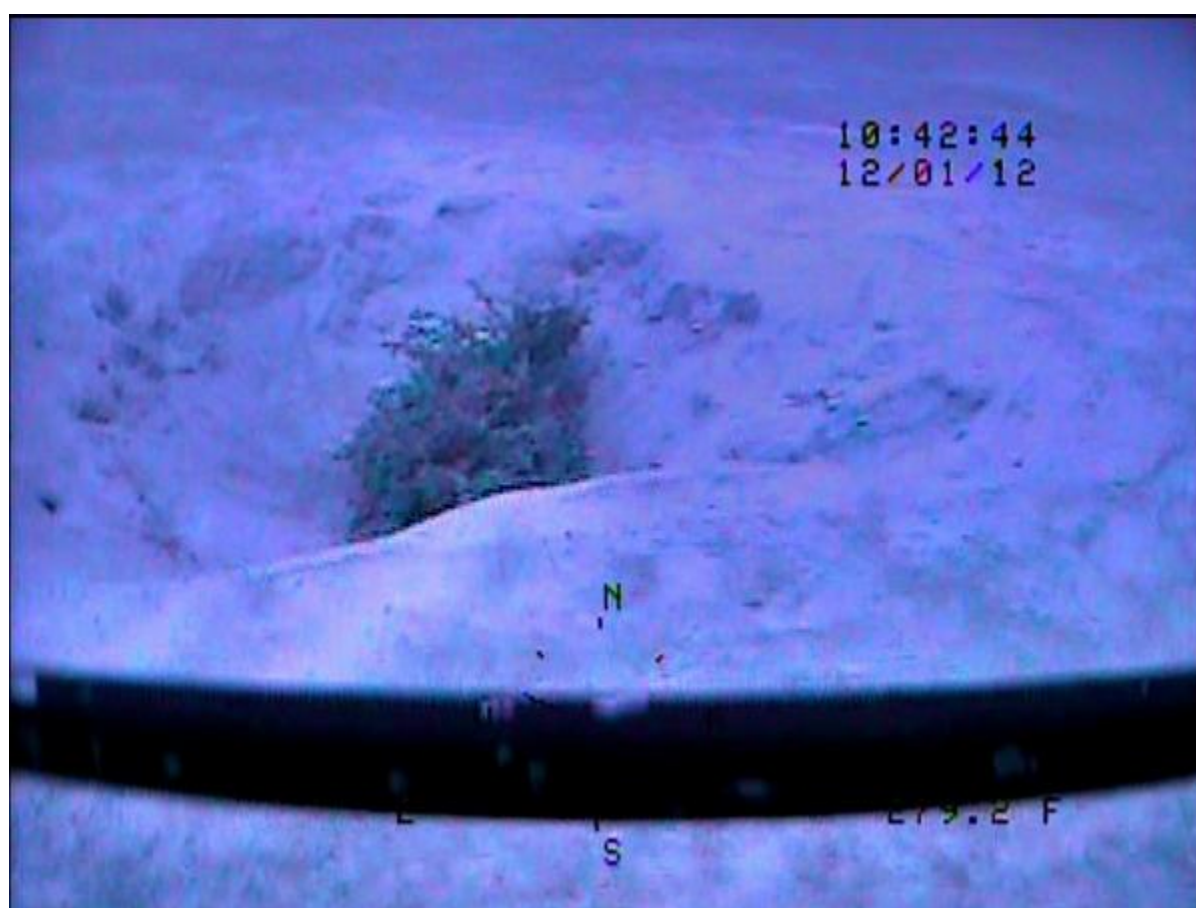
Figure 3-6: Algae in sand depression, Site 8

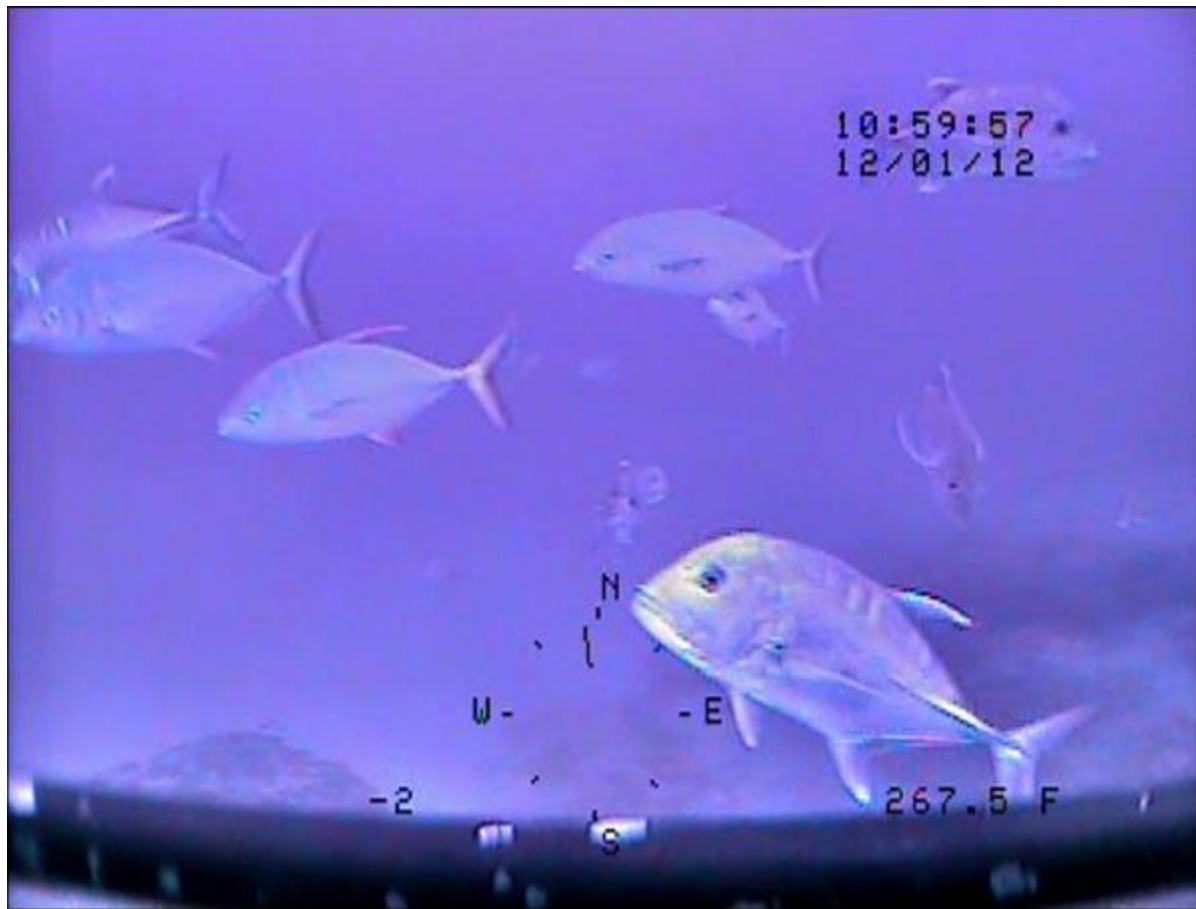
Site 10 was located at a water depth of 90 meters at an area with a 2-3 meter escarpment noted on the multibeam survey and irregular relief noted in the side scan survey. The ROV video indicated revealed a rock ledge with 2 to 3 meter vertical wall and irregular indentations. Large schools of fish were present in the area.

Figure 3-7: Fish at Site 10

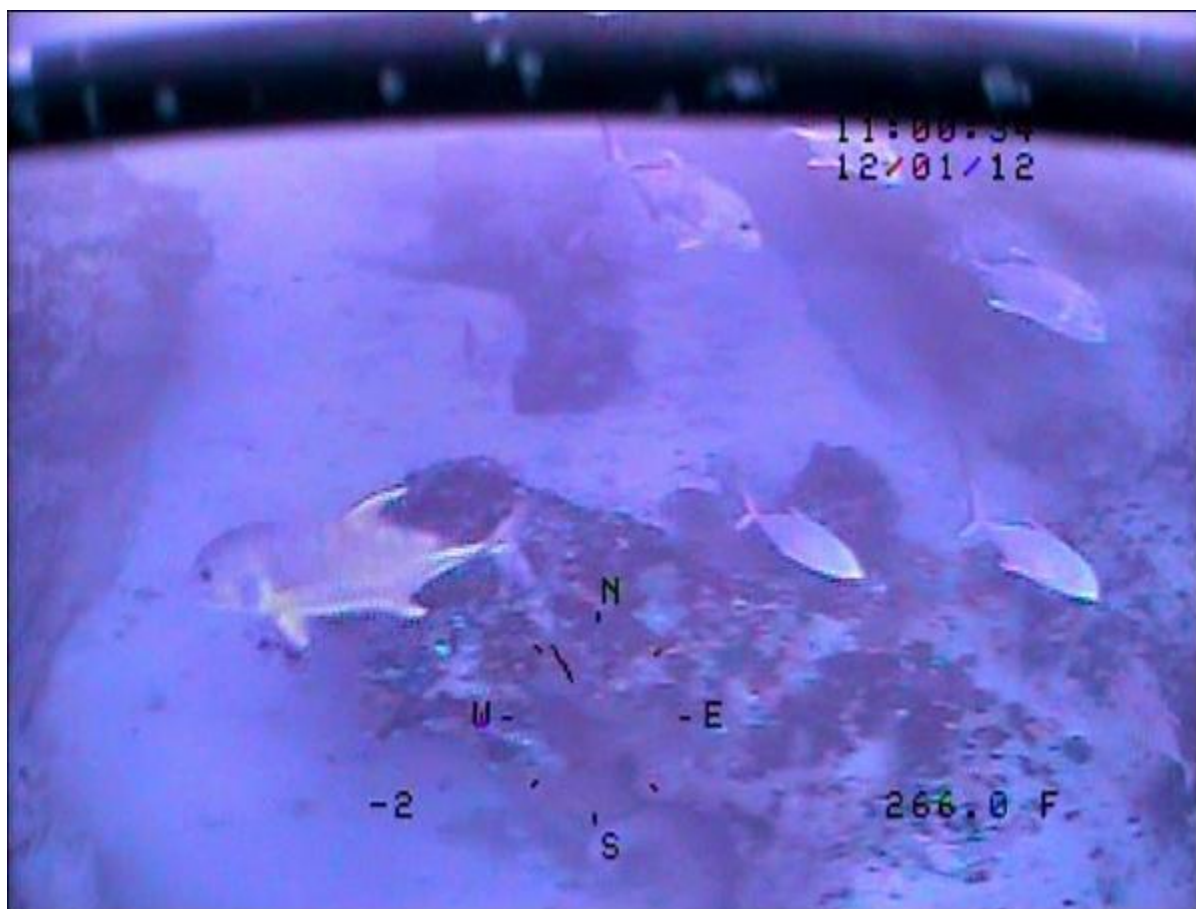
Figure 3-8: Rock ledge at Site 10

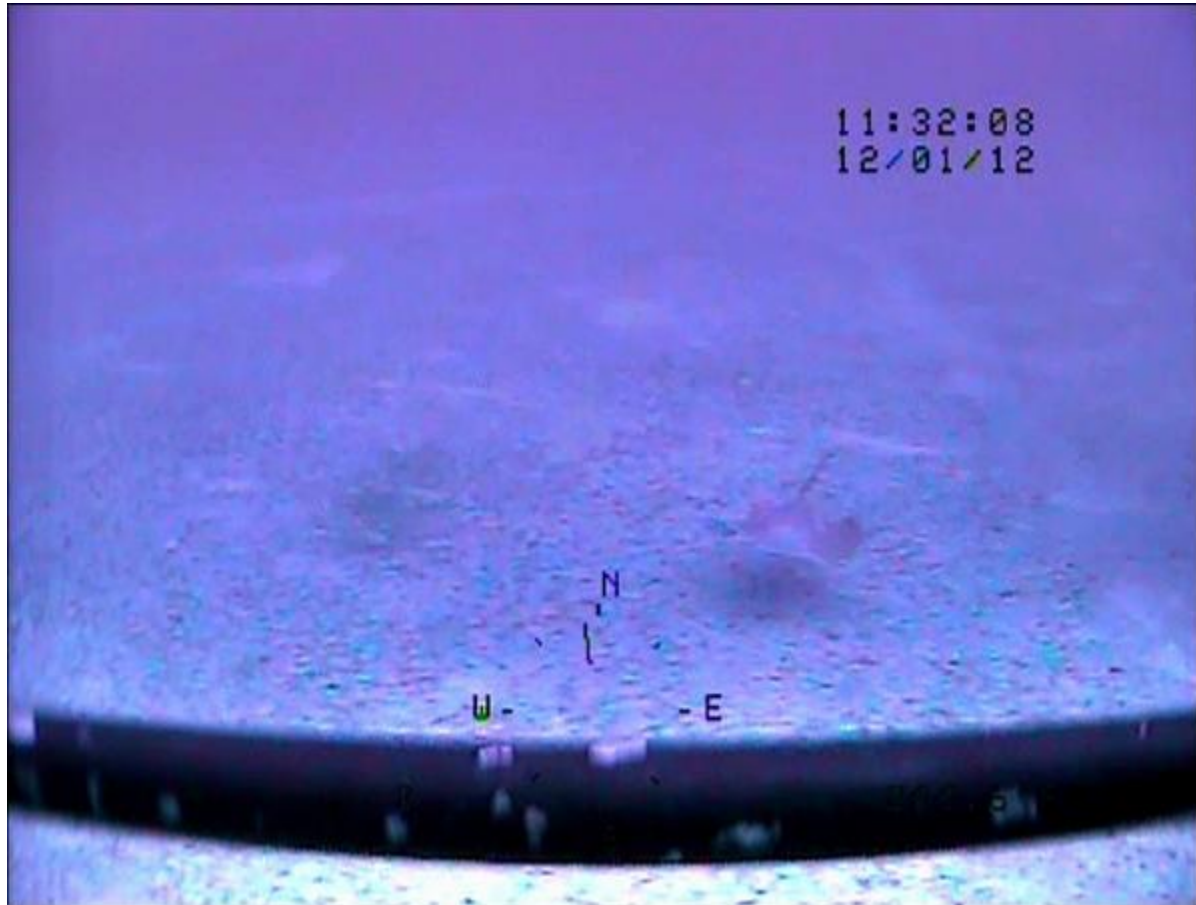
The ROV dive at Site 12 was conducted at a water depth of 87 meters along the northern edge of the test area. This area was relatively featureless in the bathymetry and side scan surveys and the sub-bottom survey did not indicate significant sand. The ROV video indicated that the bottom consisted of coarse cobbles, scattered algae and scattered thin sand.

Figure 3-9: Cobbles, thin sand and scattered algae, Site 12

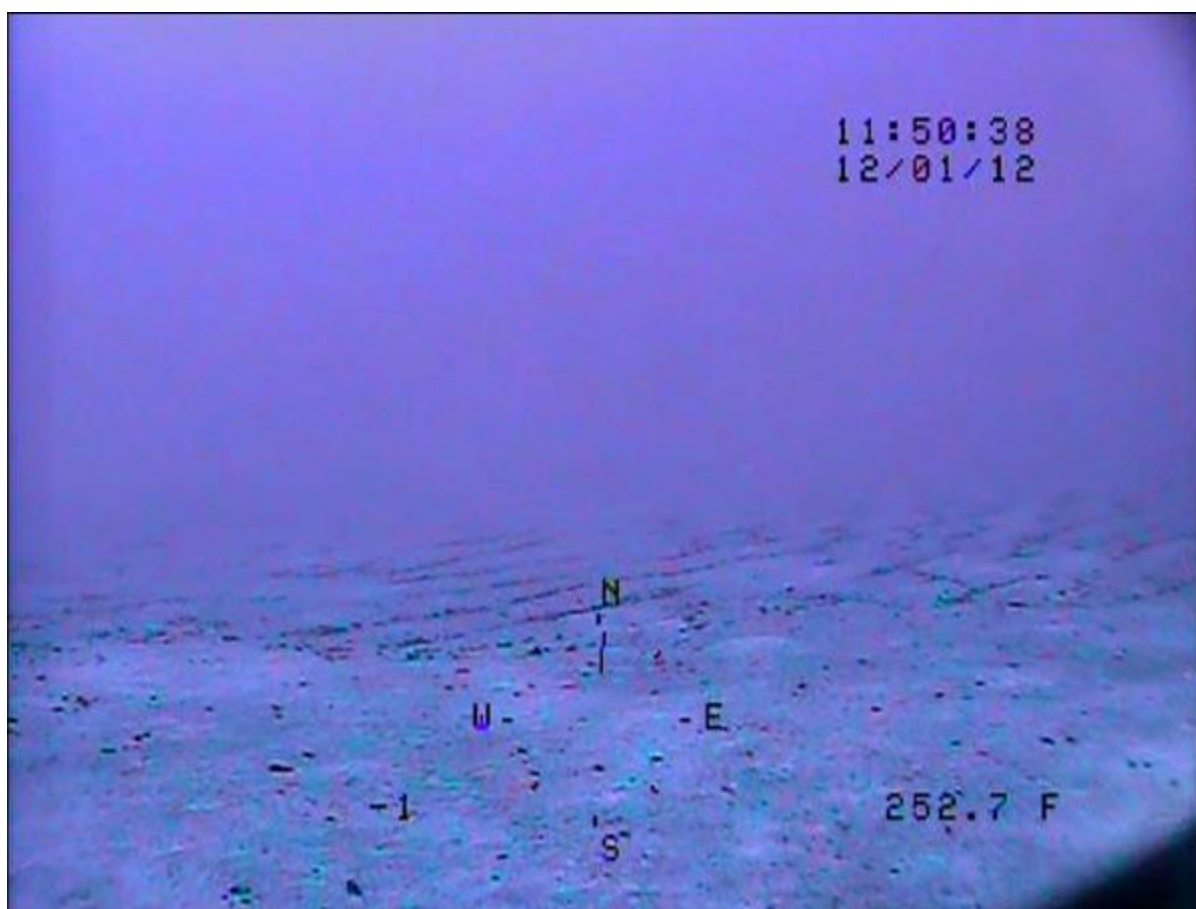
Site 11 was located within the Barchan dune area identified in the multibeam and side scan surveys at a water depth of approximately 75 meters. During this dive, the ROV recorded video along a 200 meter transect extending from the northeast to southwest. During the transect, the ROV rises up one side of a large, 1 to 2 meter high mound of sand, and then down the other side. The sand comprising the Barchan feature is coated with algae, suggesting that the feature was formed in the past, and active sand transport is not presently occurring. At the base and between the Barchan features, the bottom contained small sand ripples or waves about 1 foot apart with pebbles and algae lining the troughs.

Figure 3-10: Edge of a Barchan feature at Site 11. Barchan sand is visible in the foreground. Sand ripples with pebbles and algae in the trough are visible beyond the Barchan.

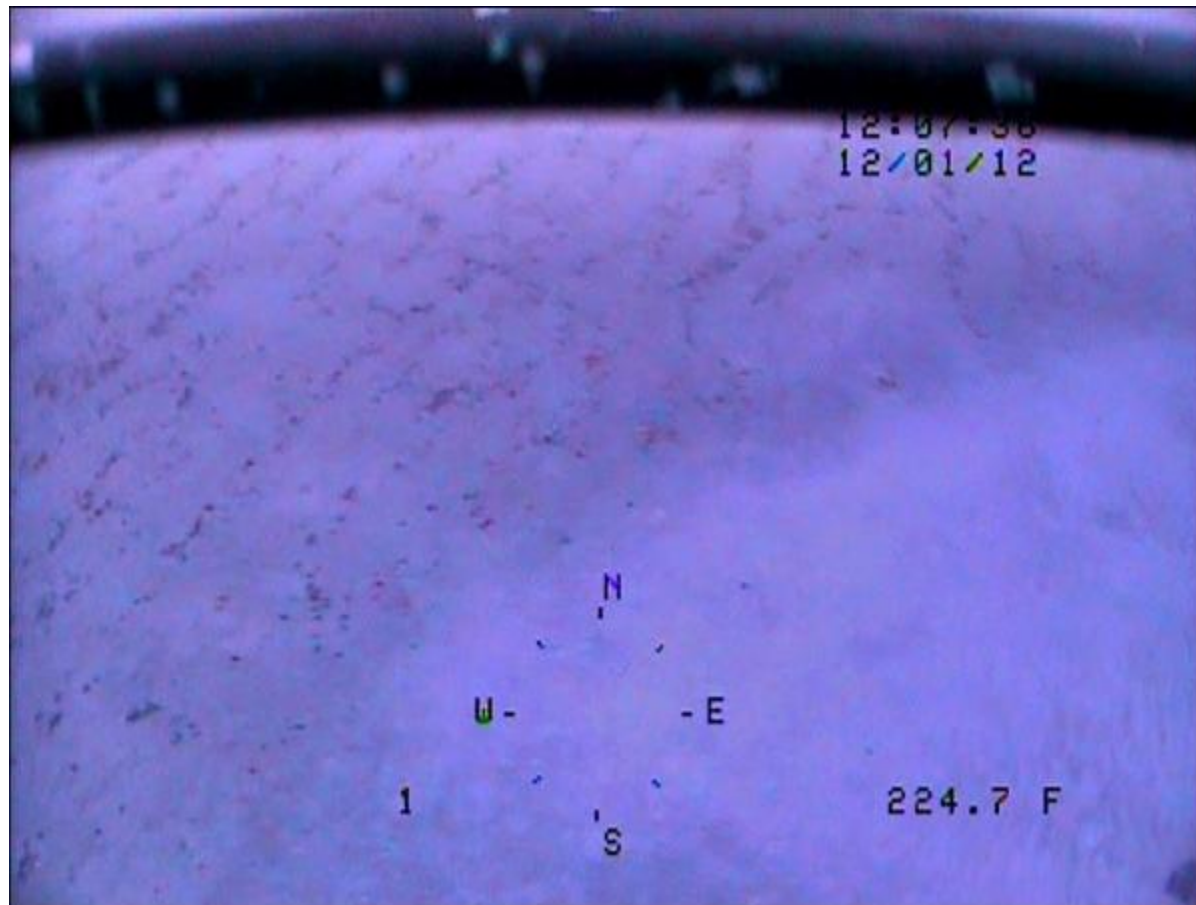
Site 9 is located at a water depth of 76 meters in a relatively flat area at the seaward margin of the thick sand deposit. The transition to the area of thicker sand is evident on the video. The ROV video clearly shows the transition from an area with thin sand cover and sand ripples, to the thick sand deposit to the southeast.

Figure 3-11: Transition from thin, rippled sand with cobbles (upper left) to thick sand (lower right) at Site 9.

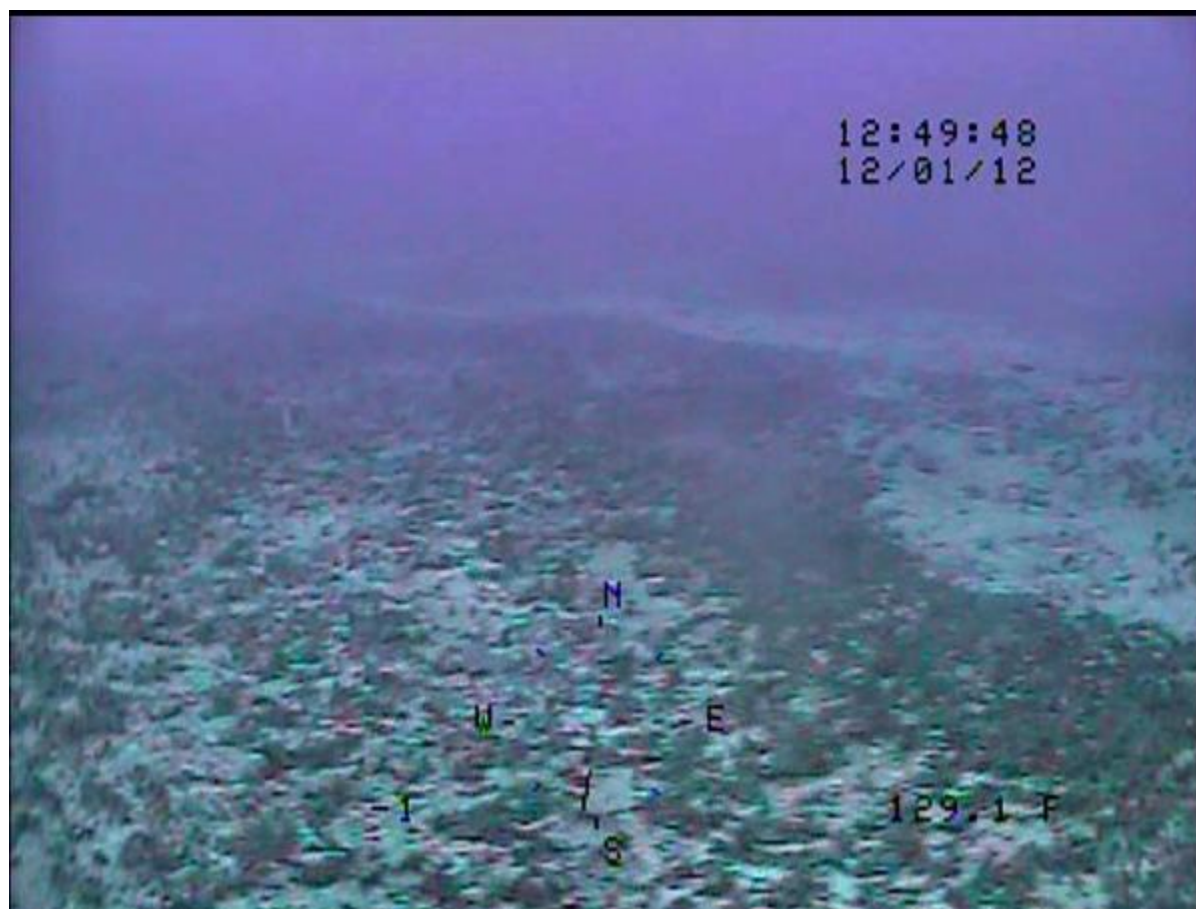
Dive 13 was conducted at a water depth of 42 to 45 meters, in an area noted on the side scan survey to have hard bottom and irregular relief. The ROV survey revealed hard bottom, with 1-2 meter relief and a spur and groove morphology. Sand was visible in the grooves while the spurs were barren, hard bottom with some algae.

Figure 3-12: Hard bottom with thin sand and algae cover, Dive 13

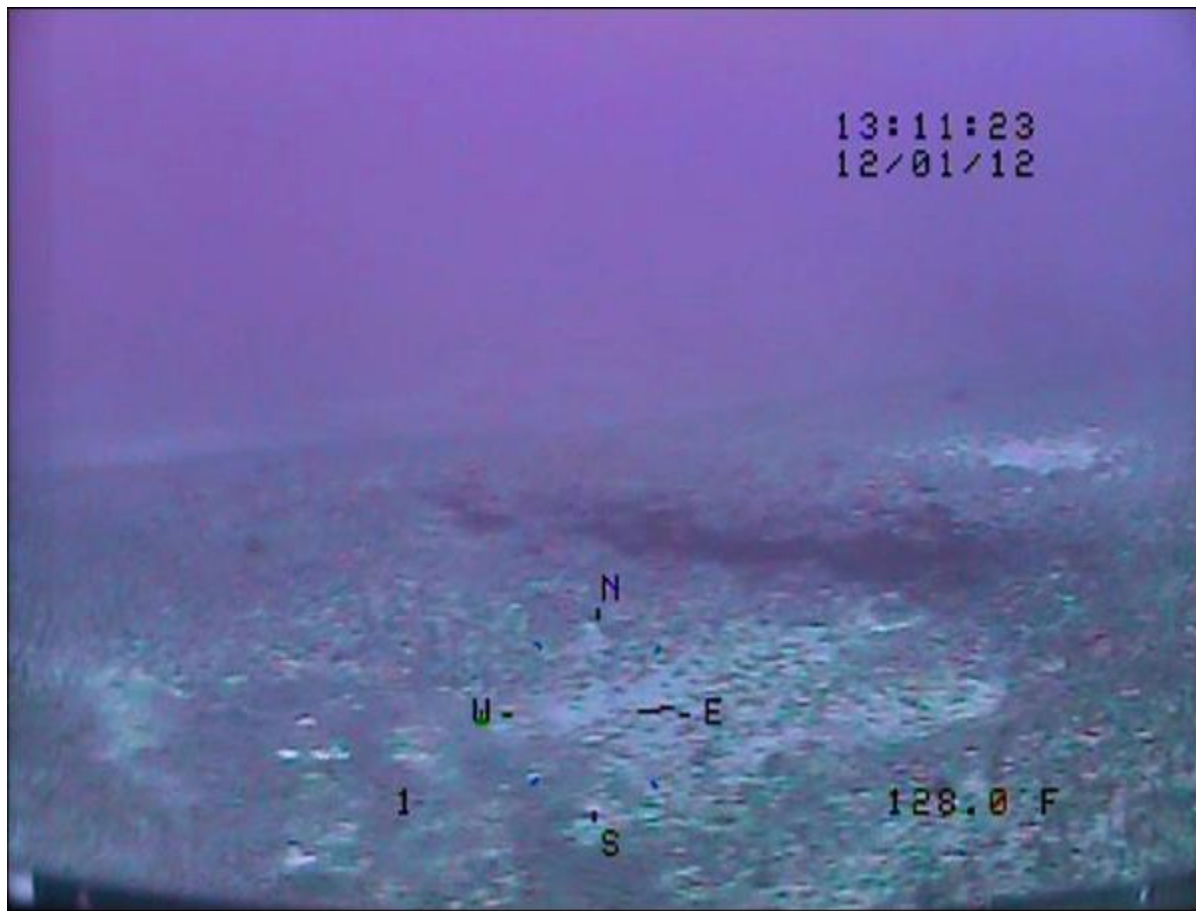
Dive 14 was conducted at the east edge of the project site on the 40 to 45 meter escarpment noted in the bathymetry and side scan surveys. The bottom consisted of reef limestone with extensive algae cover and occasional 1-meter high ledges.

Figure 3-13: Reef ledge along Dive 14

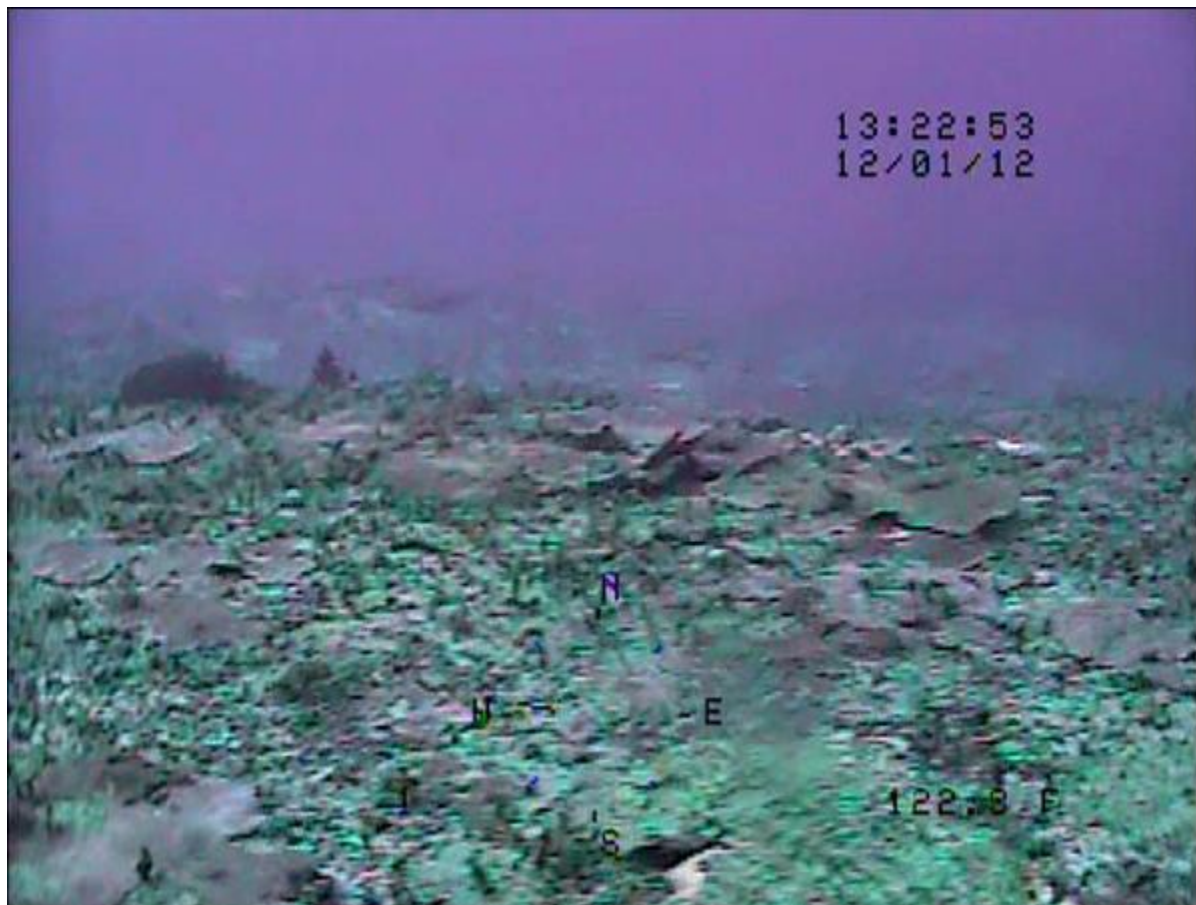
Site 15 was located at a water depth of 40 meters along the top of the 40 to 45 meter escarpment. The ROV revealed reef limestone with irregular relief and scattered, small live coral heads.

Figure 3-14: Reef limestone and scattered live coral at Site 15

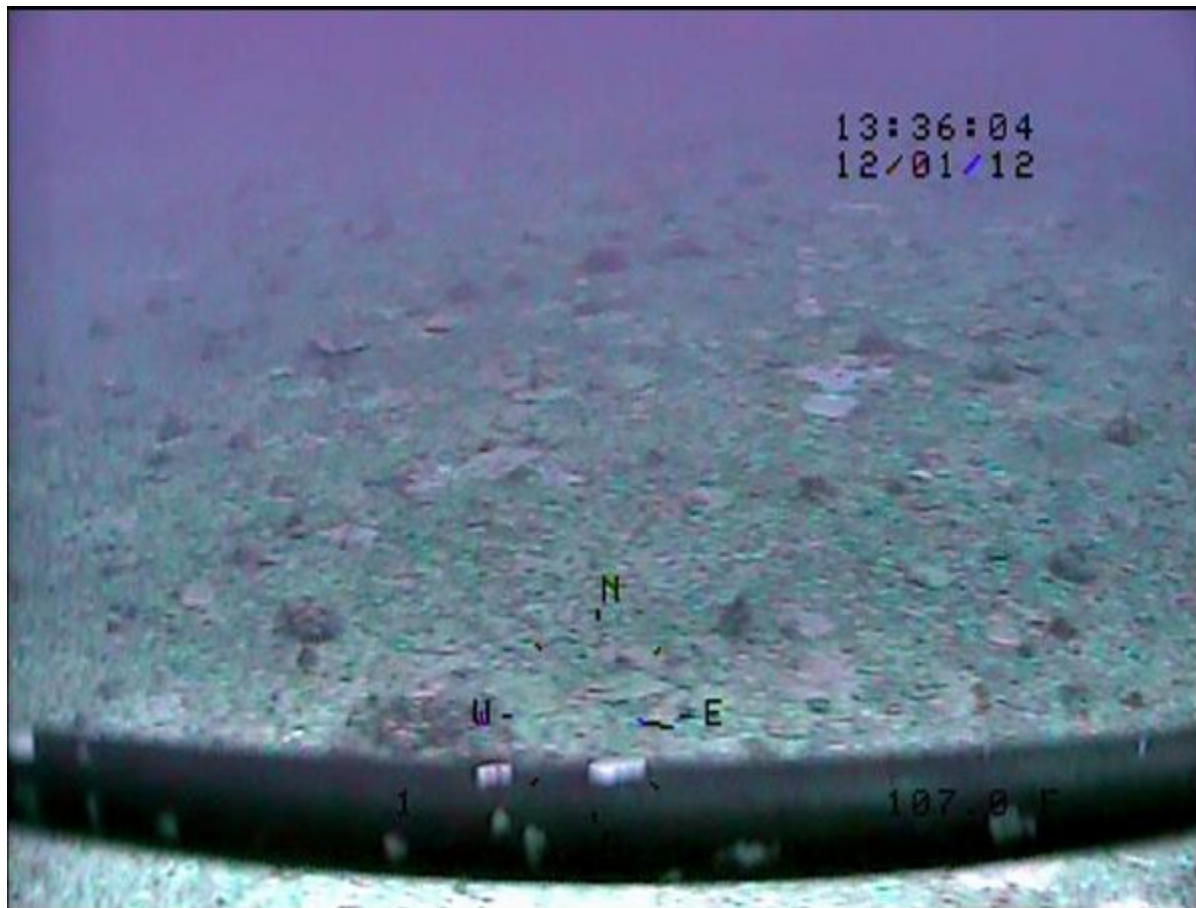
Site 16 was located at a water depth of 36 meters in a gently sloping area close to the existing OPT anchor area. Previous surveys suggested this was relatively featureless hard bottom with scattered thin sand. The ROV video survey confirmed this interpretation, showing relatively flat, featureless reef limestone bottom, with widely scattered small coral heads.

Figure 3-15: Scattered coral heads on hard bottom overlain with sand and algae
