**Report to the National Renewable Energy Laboratory
on Southwest Alaska Small Wind Wildlife Site Investigations
at Kodiak Island and Bristol Bay October 3 - 10, 2003**

December 8, 2003

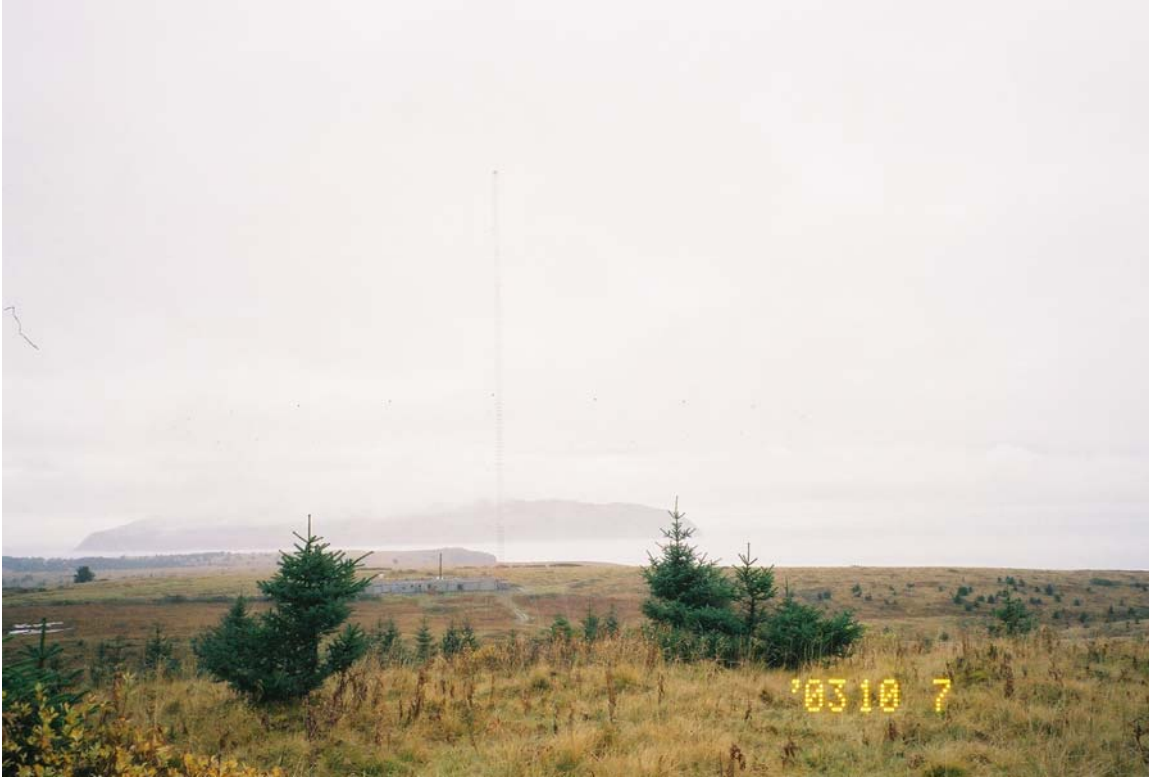
This site includes a USCG guyed Loran antenna approximately 1,200 feet tall, with buried radials that extend out in all directions beyond the guys. A short distance away is the Alaska Aerospace Launch Corporation's launch facility. The area is grazed by cattle and American bison within the Burton Ranch grazing lease. Few trees are present in this predominately meadow and low shrub habitat.

Figure 1, below, is a view looking to the southeast showing the typical habitat near the Loran antenna, with the antenna in the background.

The presence of the lagoons and lakes may cause birds traveling in an east-west direction to cut across the land part of the cape, but this is not likely to be a problem because all of the proposed facility sites are north and uphill from this low area. Based on the site visit and available information, it does not appear that a met tower and one or two small wind turbines near the Loran site or the Launch facility would have a significant adverse effect on birds in the area.

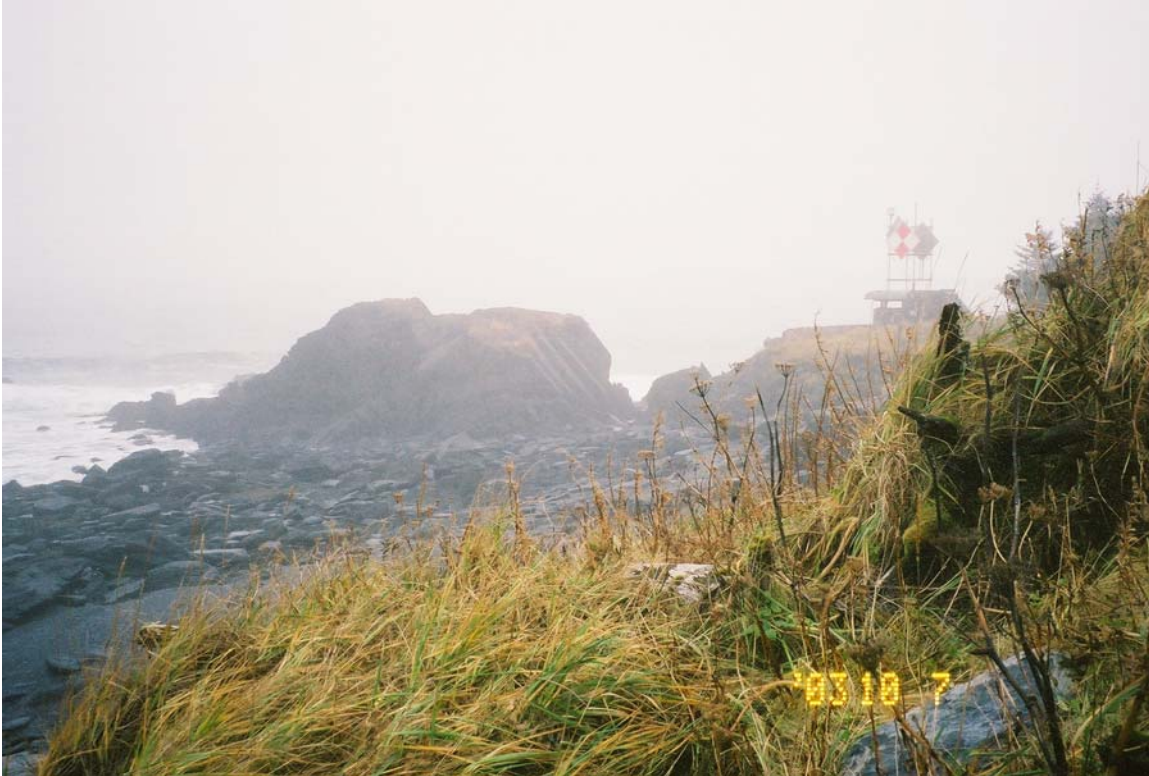
This site is a short peninsula on the eastern end of the City of Kodiak, and the headquarters for a Navy Seals training facility. The USCG has a small facility located there. Just east of the training facility buildings, there is a beach area with rocky outcrops in the intertidal zone, which supports large patches of *Fucus* and probably other algae. A short cliff face (about 10 to 20 feet high) of varying slope is vegetated with a mixture of herbaceous, shrub, and forest vegetation. Gulls were observed patrolling the shoreline during the site visit. There are a number of islands to the south and east of this cape.

Figure 2 shows the rocky coastline habitat at Spruce Cape.

The beach area does not appear to be a good location for a wind turbine because gulls patrol the beach area, the outcrop habitat in the intertidal zone would provide foraging and nesting habitat for shorebirds such as oystercatchers and turnstones, and visual

impacts could be an issue with the public using the shoreline and beach to the east. A turbine in the meadow area would put fewer birds at risk from collisions than one closer to the beach, unless the site was directly on the flight path used by marbled murrelets commuting between their nests and the ocean.

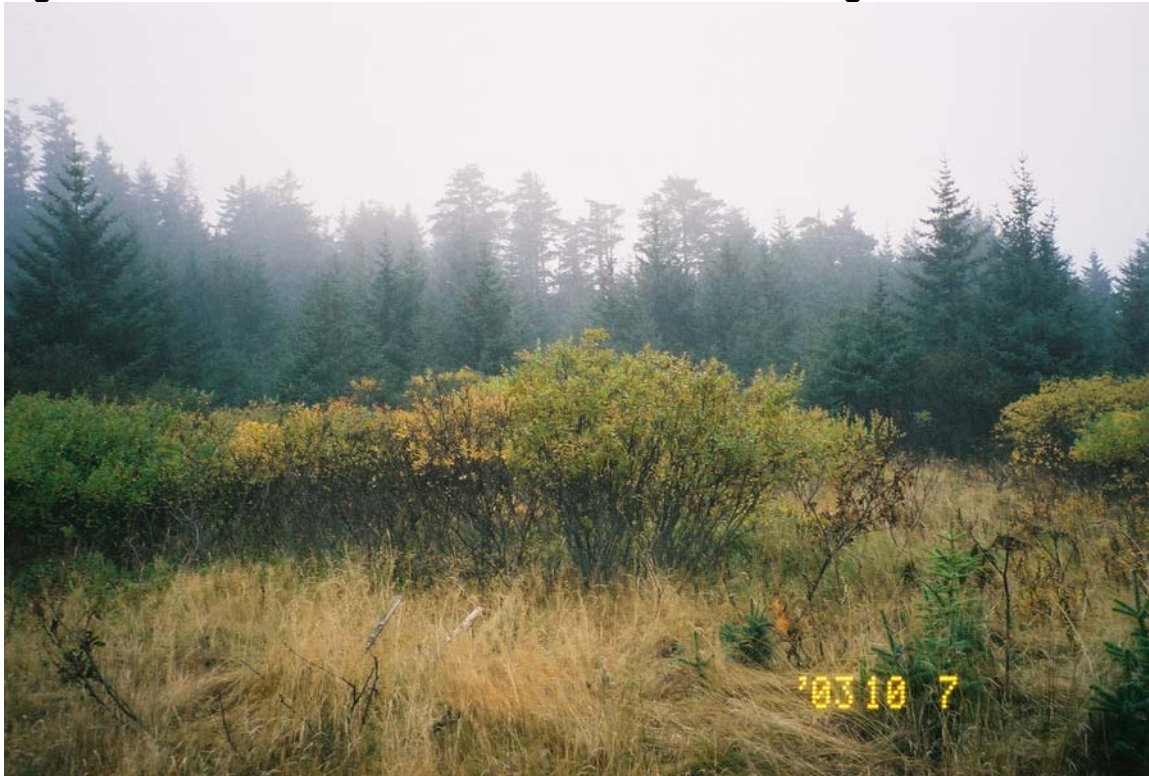
Farther east, to the north of the chain link fence that parallels the coastline, there is a patch of emergent wetland, patches of Sitka spruce, and a more upland meadow and willow shrub complex. In the middle of this upland meadow (which has been partially filled with gravel to improve vehicle access) is a small beacon of some kind approximately 8 feet tall, which appears to be connected to the Navy facility through a conduit. There is sufficient meadow area available for a met tower. A forest of Sitka spruce is located to the north of the meadow.

Figure 3 shows this meadow with the forest in the background.

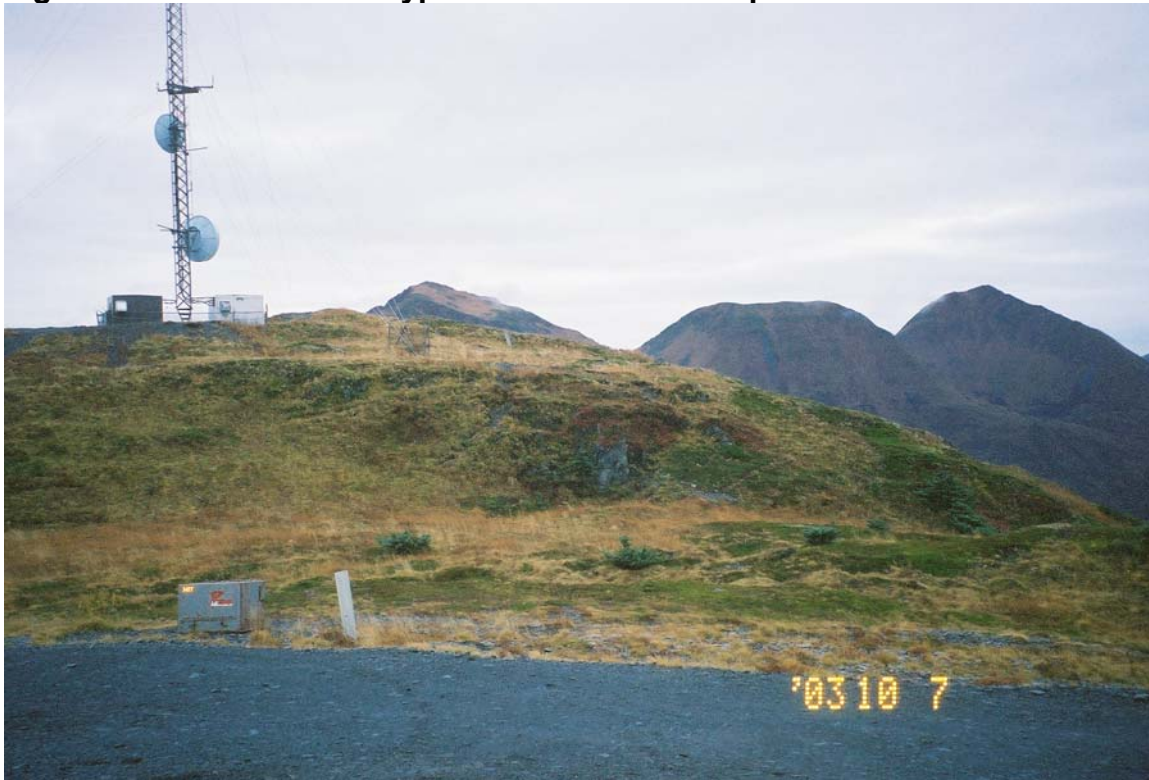
The habitat is tundra with a very few low windswept Sitka spruce (Figure 4). There is a good access road, and nearby transmission line and substation located further down on the slope of the mountain in forest habitat. There are also a number of existing communication towers, so the addition of turbines would not constitute an intrusion into a pristine area. The birds observed during the site visit included small groups of common ravens flying north from the area below near the City of Kodiak (perhaps from a communal winter night roost). The ravens passed over the top and sides of the mountaintop and appeared to be spreading out over the area to forage. The ravens were flying at elevations above ground of between 10 and 100 feet. Two common snipe were flushed from a puddle in the tundra near the first communications towers along the road, and a flock of redpolls or pine siskins flew southward over the site, probably within an elevation above ground that would be within the rotor swept area of a 225-kW or larger machine. This area is probably used by ground-nesting passerines and shorebirds during the summer. A northern shrike was observed perched on a small spruce next to the road a few hundred yards downhill from this site.

Figure 4 shows a view of typical habitat on the top of Pillar Mountain.

From a bird use standpoint, it appears that the risk to birds at this site would be relatively low. Since many of the towers at this site are guyed, the existing risk of fatalities from the guyed towers could be higher than that from wind turbines, unless the turbines were also guyed. Lapland longspurs and Pacific golden plovers are night migrants, and migrating longspurs and neotropical migrants have occasionally been killed in large numbers by collisions with lit communication towers. Therefore it is possible that night migrants could be attracted to and collide with the communication towers (or wind turbines if they were lighted) during poor visibility conditions.

If wind power development is seriously considered for the Pillar Mountain site, we recommend that standardized carcass searches be conducted at the existing communications towers to determine whether this site already causes bird (and possibly bat) fatalities, and the estimated number of those fatalities.

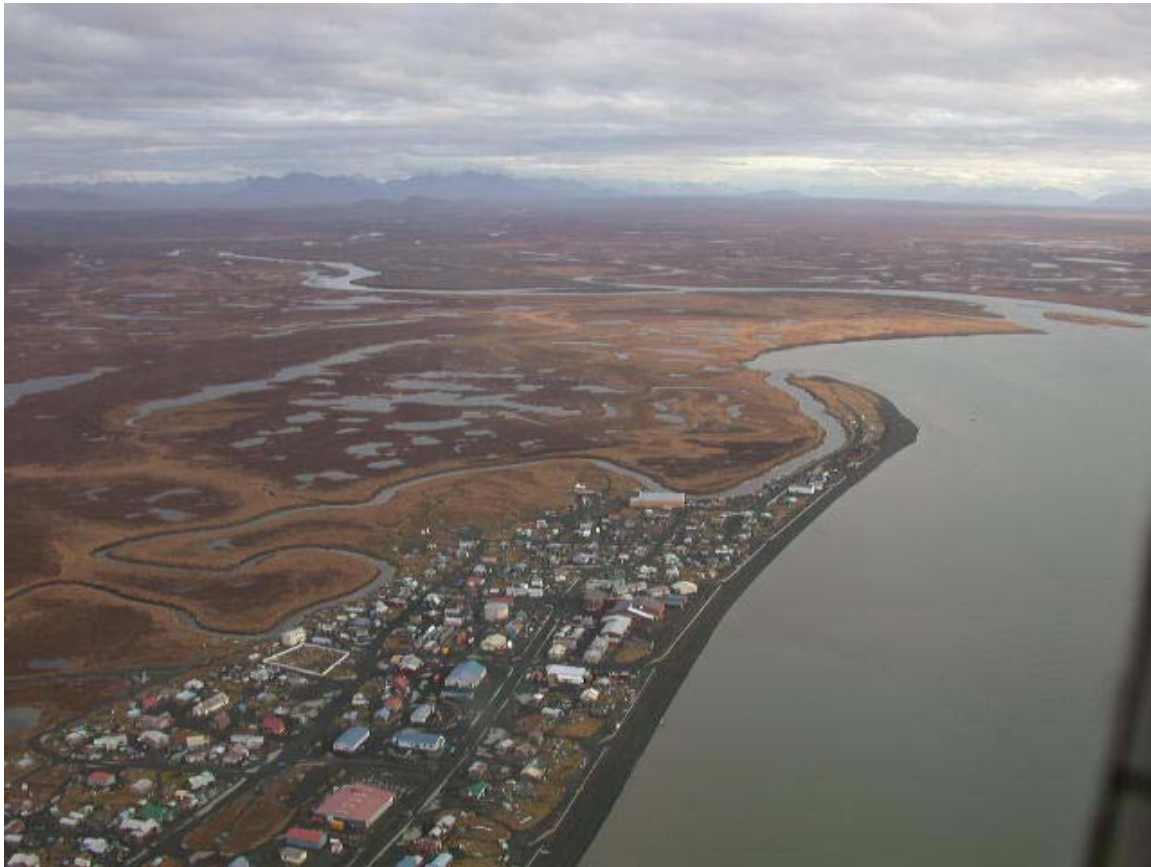
Habitat at this site is not unique to the area and the preferred site is located along a road traveled by residents living at a nearby housing development and by people traveling to the school. No unique wildlife or high value nesting habitat was noted or could be expected to occur at this location due to the existing disturbance.

Figure 5 showing an aerial view of Togiak

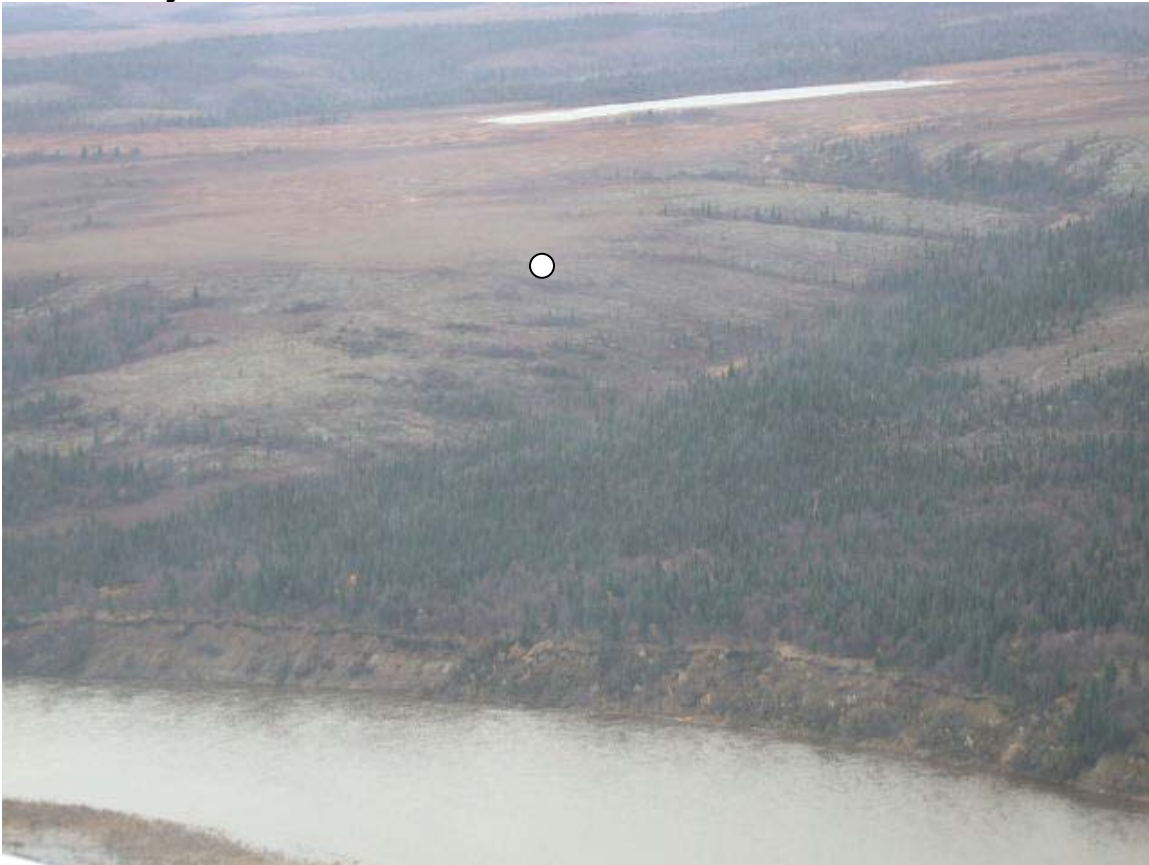
As described in Wade's (2003) report, the preferred location for the met tower (ANS Met 1) and subsequent wind tower(s) is an area that is already disturbed from previous human activity (aircraft landing, etc.). It is being used as a staging area for some construction equipment related to the new airstrip. Utilizing areas already disturbed should result in lower direct impact to wildlife from the construction of wind towers because the area is of lower quality than nearby undisturbed habitat. There were no features that would attract birds to the site such as open surface water or trees for perching. ANS MET 2 and 3 are in higher quality habitat but 2 appeared to have some human activity on a regular basis. Met 3 is open native grassland with trees in the drainages. This site may have higher wildlife use and could result in more impacts than Met 1 or 2.

Figure 6 shows the approximate location of the “future met tower” ridgeline at New Stuyok

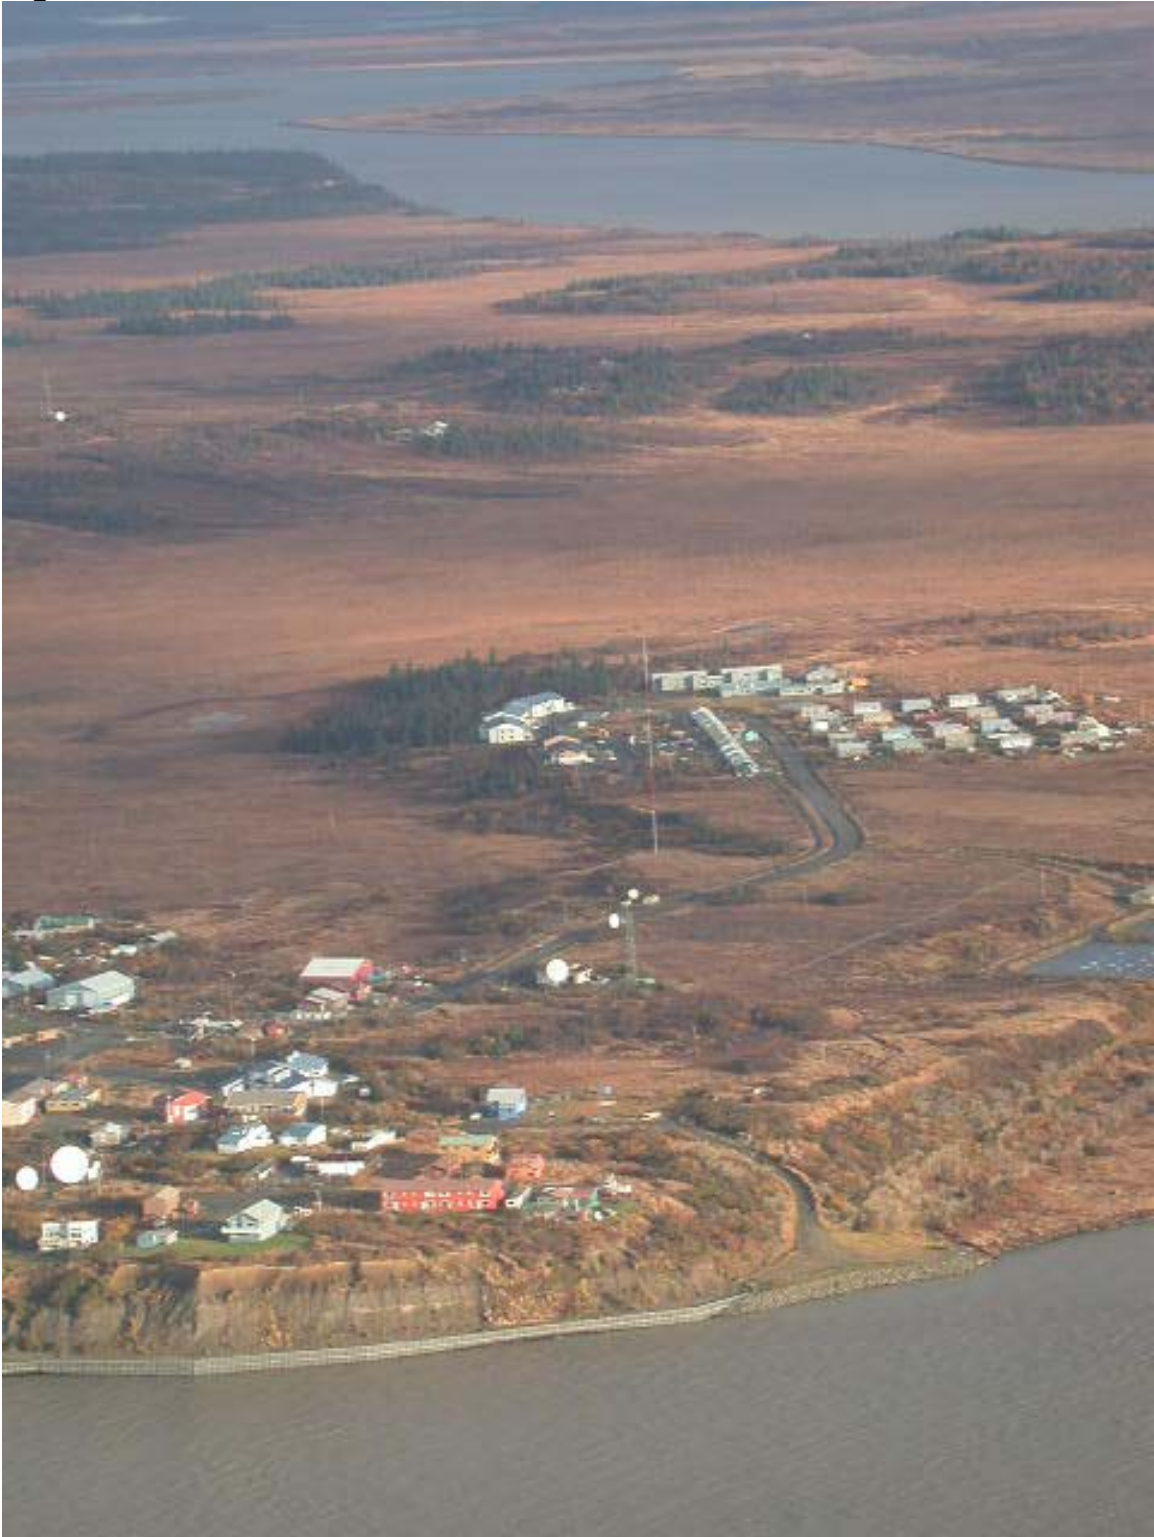
China Cap and Wood River Road are described by Wade (2003). Habitat photos are provided in his report. China Cap is more exposed on the landscape than the Wood River Road site. Night migrating passerines may fly closer to the ground here than at Wood River Road but avian use is not expected to be high according to MacDonald (pers. comm., 2003, see information review section below). Local residents were asked about bats and no one has seen any in the area. There are no trees on the ridgetop but there are some low shrubs and trees near the Wood River Road site. There were no unique features at either site that might indicate the need for protection of a resource or any unique wildlife activity.

Figure 7 shows an aerial view near the Wood River Road site.

Based on the available information, it appears that wind turbine placement at any of these sites would not represent a significant risk to birds.
